PRELIMINARY RESEARCH FOR THE RESTORATION CONCEPT OF MARBLE PANELS FROM THE STOCLET PALACE IN BRUSSELS

Hilde De Clercq*, Maja Jovanović
Royal Institute for Cultural Heritage (KIK-IRPA), Jubelpark 1, 1000 Brussels -Belgium

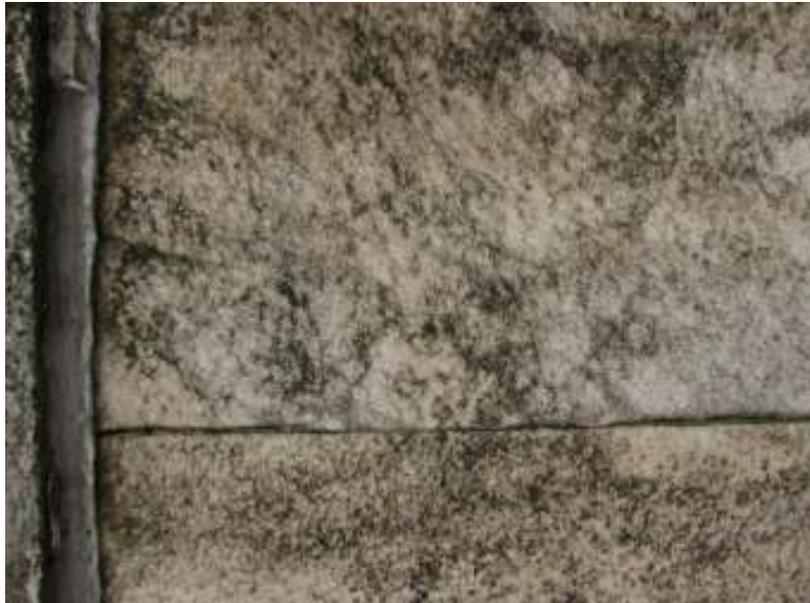
The marble panels, however, are presently suffering from diverse deterioration phenomena, such as polish loss resulting from exposure to acid rain, biological contamination, formation of black crusts (Fig. 2), anisotropic dilatation of constitutive minerals (Fig. 3) and deposition of corrosion products from the bronze sculptures and decorative elements (detail on Fig.3).

Figure 2: Black crust

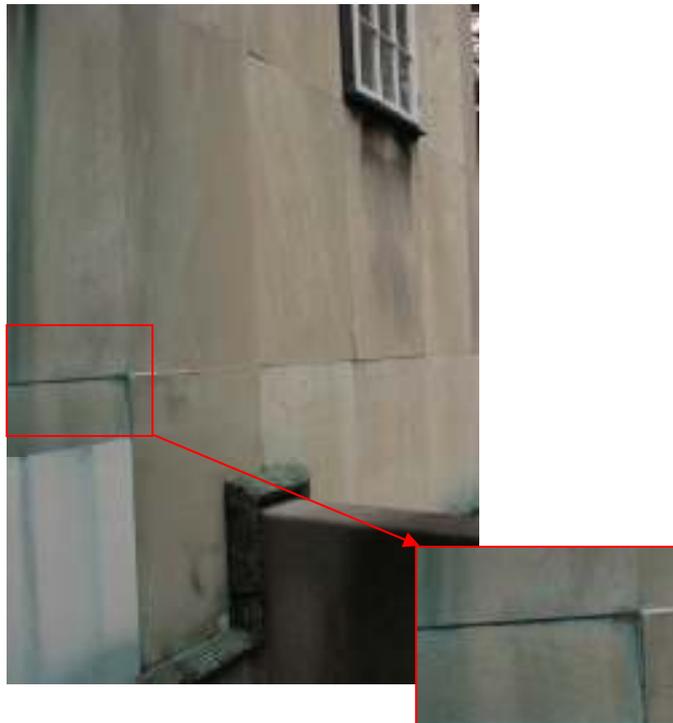
Figure 3: Marble panel deformation resulting from the anisotropic dilatation of constitutive minerals; the detail shows deposition of corrosion products

The granular disintegration of marble is a well known phenomenon [2-4]. Most minerals present a dilatation that is not equal in all directions. Exposure to temperature cycles, i.e., alternating

warming and cooling, results in irreversible deformations that are enhanced in the presence of moisture. During warming, pores and micro fissures between constitutive grains are formed and increase the porosity and permeability of the marble. During cooling, the micro fissures tend to close, but not completely: hence a marble panel won't return to its original dimension. The residual porosity accumulates after successive cycles through which the generation of products from bronze sculptures and decorative elements occurs. The latter are a quite common problem whenever marble and bronze are combined in one monument. When the corrosion products, composed mainly of copper oxides, hydroxides and salts, are absorbed by the material, they suffer some chemical changes that firmly fix them to the substrate and their removal is therefore quite difficult [5].

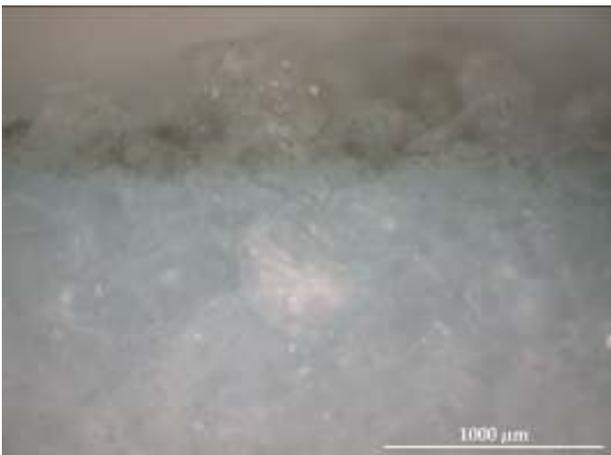
Figure 4: Optical microscopic analysis of a sample taken from the backside of the main building, a detail of the superficial layer

Optical microscopic and SEM-EDX analyses of the surface layer of a moderately deteriorated marble panel of the palace are shown in Figs. 4 and 5 illustrating granular disintegration giving rise to the deposition of copper corrosion products, including CuCl_2 , in the micro fissures.

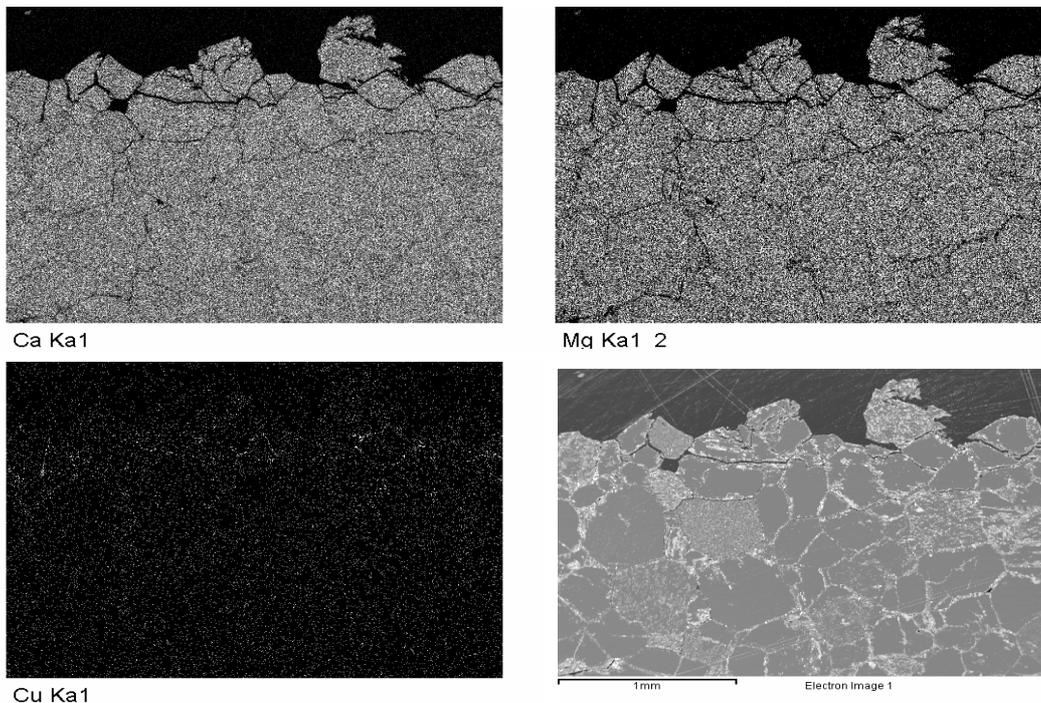
Figure 5: Mapping of calcium, magnesium and copper of the surface layer presented in Fig. 4

illustrating granular disintegration; Down, right - image of the same superficial layer obtained by backscattered electrons (SEM-EDX)

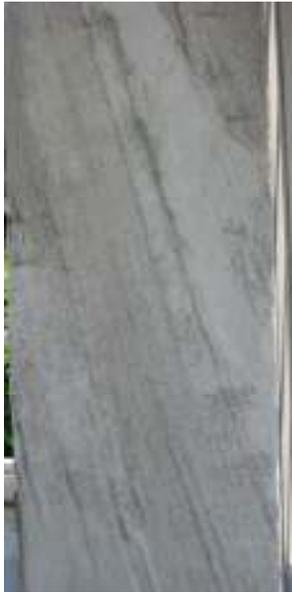
The thickness of marble panels is between 30 and 35 mm. While most of them are moderately deteriorated, some panels surrounding a terrace are highly degraded (Fig. 6), having a very low cohesion to a depth of at least 10 mm, representing about 30% loss of structural strength of the panel.

Figure 6: One of the strongly deteriorated marble panels surrounding a covered open terrace (inside part)

Hence, an effective and long lasting conservation of the highly degraded panels of the palace is considered impossible at this time and since their stability is seriously compromised, replacement is recommended.

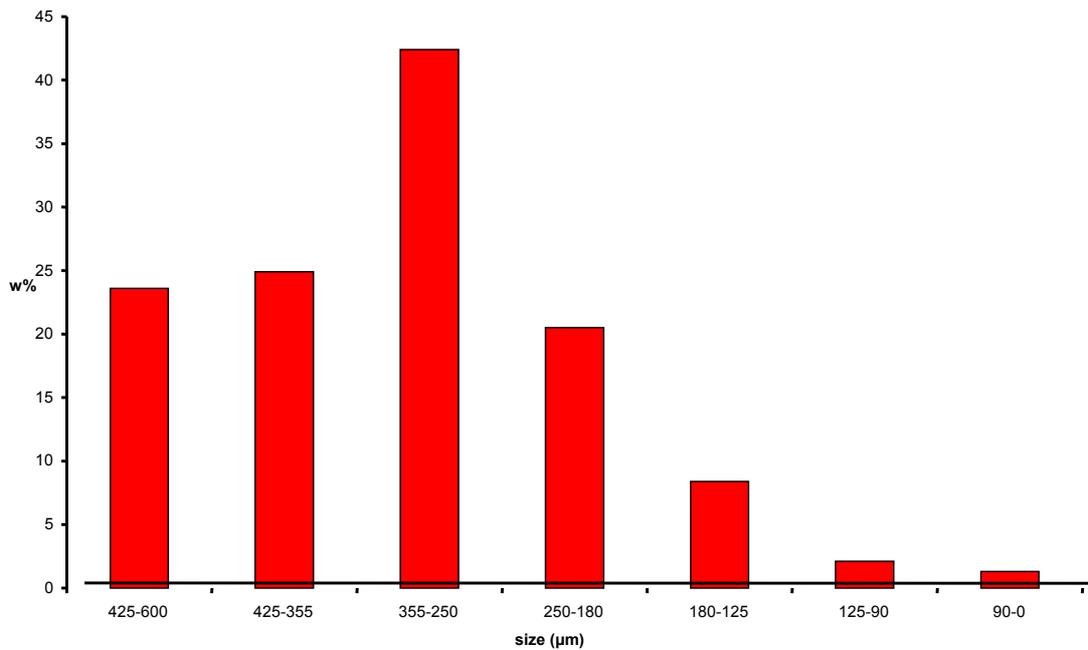
Fig. 7 illustrates the grain size distribution of the dolomitic marble after gently grinding a sample of the panel presented in Fig. 6.

Figure 7: Grain size distribution of the ground dolomitic marble from a sample of the panel shown in Fig.6

As shown in Fig. 7, the dolomitic marble has, apart from small grains below the 325 μm limit, a rather large proportion of dolomite crystals that are significantly larger in size. These larger grains are beyond the limit of grain sizes that, in case of a powder, can be effectively consolidated with TEOS. However, an experimental approach is needed to confirm that marbles having this grain size distribution may not be consolidated since the space between the crystals is a critical parameter.

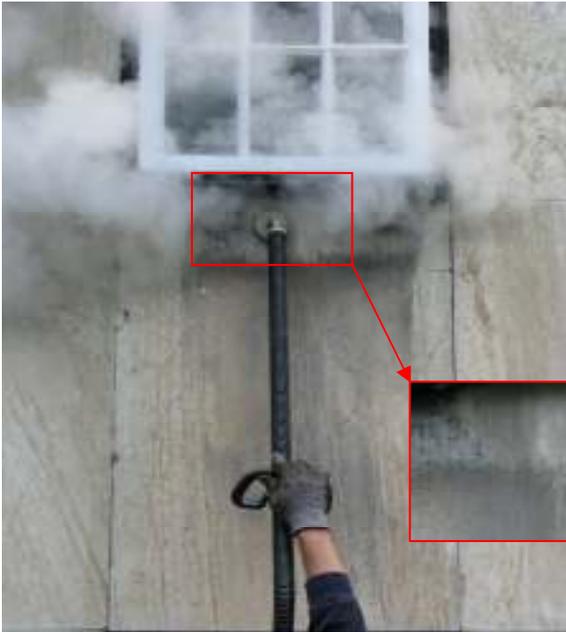
The cleaning using water vapour (150 °C) at a pressure of 30 bar (3 MPa) is a slow and soft procedure that only results in the removal of superficial dust. The surface of the marble panel showed almost no mechanical damage after cleaning even on zones presenting a low cohesion (Fig. 8). Black crusts could not be removed by means of this soft cleaning technique (see detail on Fig. 8) and hence the original aspect of the marble could not be regained. Even the addition of a non ionic tensio-active agent did not improve the cleaning efficiency.

Figure 8: Cleaning of a marble panel with water vapour (150°C, 30 bar (3 MPa))

Detail: a degraded zone of the marble panel in between undegraded zones showing a black crust after cleaning

Black crusts formed by the chemical transformation induced by air pollutants could not be completely removed without important material loss in degraded marble zones. Hence it was recommended to use a soft technique that removes superficial dirt of moderately deteriorated panels, such as warm water at 30 bar (3 MPa).

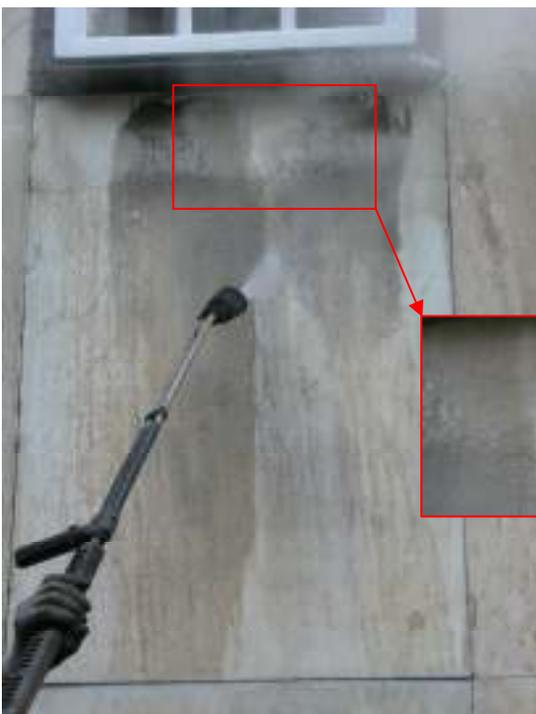
Warm water (80°C) at a projected pressure of 80 bar (8 MPa) enabled a fast and moderately efficient removal of the black crusts (Fig.9). However, due to the high pressure, important material losses at zones of the marble panel showing surface degradation could not be avoided (see detail on Fig. 9).

Figure 9: Cleaning of a marble panel with warm water under pressure (80°C, 80 bar (8 MPa))

Detail: material loss on a degraded zone of the marble panel after cleaning

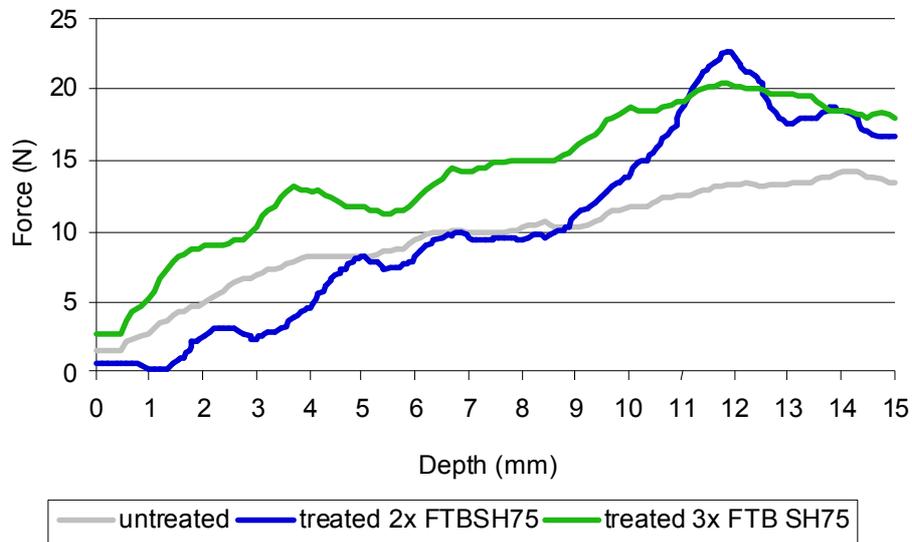
Fig. 10 presents the hardness profiles of the highly degraded marble panel presented in Fig. 6 before and after consolidation with the simple TEOS formulation. The untreated marble panel as such shows a low hardness, which is even more pronounced for the surface layer of at least 10 mm depth. The consolidation effect of two or three applications with TEOS, for which the consumption was respectively 1300 and 2200 $\text{g}\cdot\text{m}^{-2}$, was considered insufficient since the mechanical strength of the surface layer hardly increased. Handling the consolidated samples made the presence of loose material evident. This was also the case after consolidation with the elastified TEOS formulation. This poor result can be attributed to the significant fraction of large crystal sizes in this marble as discussed above (Fig. 7).

Figure 10: Average hardness profile of samples taken from the highly degraded marble panel presented in Fig. 6 before and after consolidation with a simple TEOS formulation.

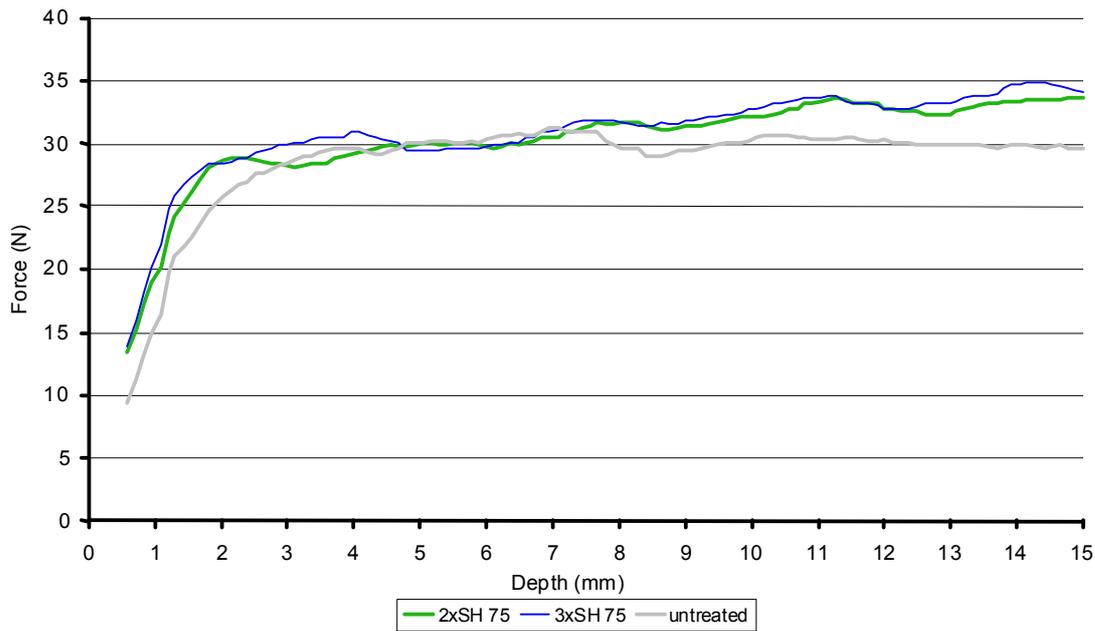
Fig. 11 illustrates the average DRMS-results obtained on samples from moderately deteriorated marble panels. Before treatment, the marble shows a deteriorated surface layer up to 5-6 mm depth, hence corresponding with the impregnation depth of the consolidants (Table 1). A remarkable difference in hardness compared to the highly degraded panels (Fig. 10) is noticed. Two applications with FTB-Remmers SH75 result in an increase of the surface layer hardness quite comparable to that of the underlying sound zone (Fig. 11). A third application does not improve significantly the strengthening properties. Similar results were obtained after treatment with the elastified TEOS product. Fig. 12 compares the hardness profiles of moderately deteriorated marble after two applications with both types of strengthening products and one before treatment. This shows that a slightly better consolidation effect is obtained with FTB-Remmers KSE 300. Moreover, water absorption tests with the Karsten pipe according to [16] revealed no water uptake during 15 minutes, whereas the samples treated with the simple TEOS consolidant still showed some water uptake (0,05 ml), that already is low compared to the average one measured on the untreated sample (0,30 ml).

Figure 11: Average hardness profile of moderately deteriorated marble panels before and after two or three applications, wet-on-wet, with a simple TEOS formulation.

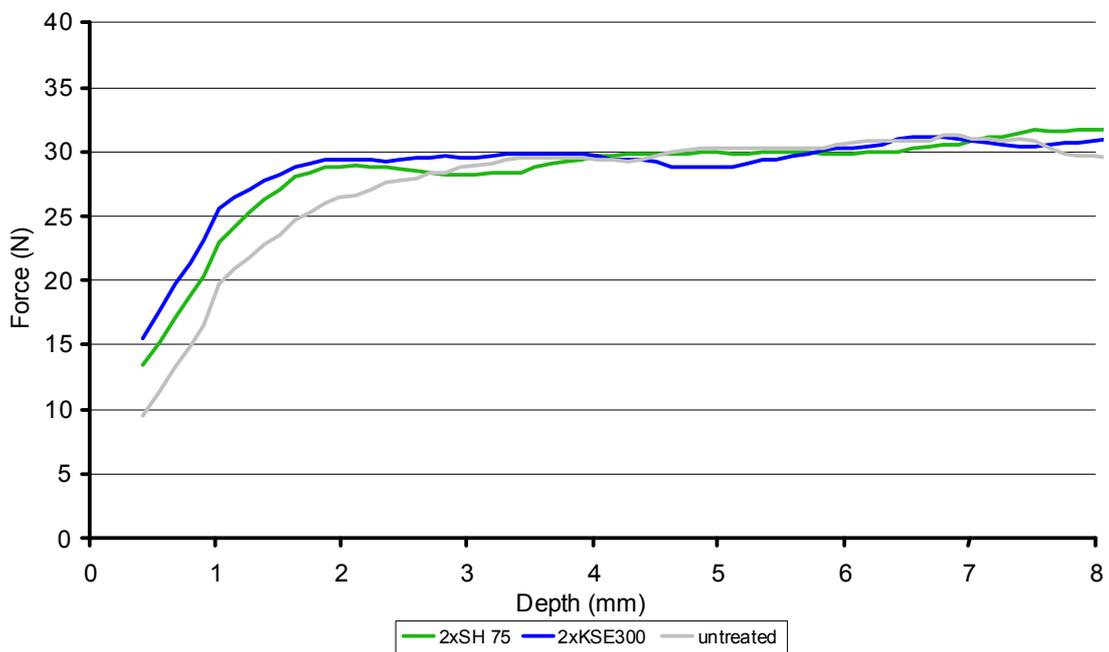
Figure 12: Average hardness profile of moderately deteriorated marble panels before and after two applications with the simple TEOS consolidant (FTB-Remmers SH75) and with the elastified TEOS formulation (FTB-Remmers KSE 300)
