DRUMS' FRACTURE-THE EXAMPLE OF THE 6TH COLUMN OF PARTHENON'S PRONAOS

Marilena Mentzini

Structural Engineer, PHD, Ministry of Culture and Tourism, 6th Ephorate of Prehistorical and Classical Antiquities

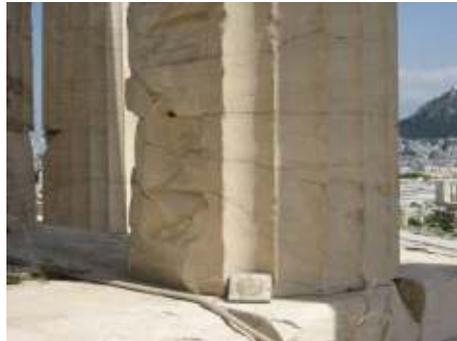
Figure 1:
The 6th column from NW

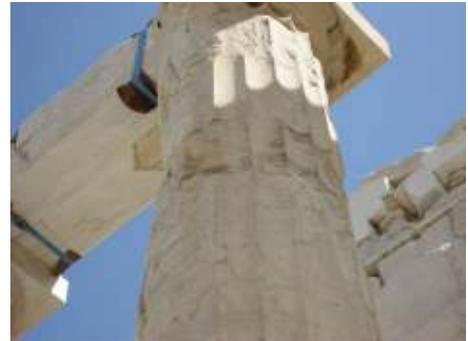
Looking towards the 6th column of Parthenon's Pronaos it can be directly observe the thermal fractures stretch along its height and in which way they embrace the drums' surface in the SW area. As it clearly seems the fire's limits are connected to the place of the marble's carvings that determines the position of the wooden parts of the ancient diaphragms and thus it is concluded that the burn of the column came from the interior of the temple (Fig.1, 2). The extension of fire's trace all over a whole flute in the surface up to the 10th drum (drums' counting starts from the first one (drum) settled on the stylobate) is the effect of the remaining mortise (which implies a wooden holder) but also yields to the existence of the ancient south window of the east wall which is opened in this exact height and helped fire to spread (Fig.3). The beginning of the fragments' creation in this particular section due to the fire, judging from their bowed shape as it is already mentioned, but their evolution to clear, even bigger pieces, some of which have already fallen leaving their prints on the remaining fractured cross section, due to other reasons.

Figure 2: Start of the thermal fracture in the mortise's area

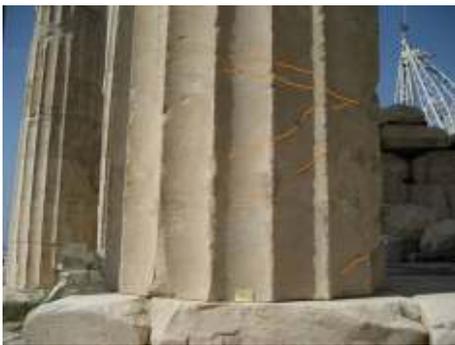
Figure 4

when the material layers have the same direction, the cracks are easily transferred from one drum to the other, i.e. finally any conjunction all over the contact surface gives more or less unfavorable results (Fig 4-10, 22 pointed by a circle).

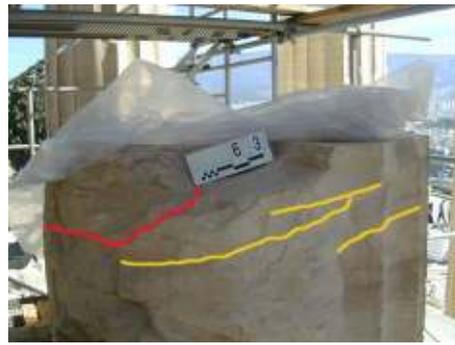
Figure 5

As far as it is concerning dynamic actions –in our case earthquake and explosion, drums may decline (raise themselves) from the horizontal state, while the rocking effect produces impact phenomena among adjacent members. The conflict damages particularly the edges of the contact area between them, which is linear and consist schematically an arc. The result produces fragments which usually form wedges and the presence of converging strata –as it pointed out before- make easier the start of the failure (Fig.5, 11).

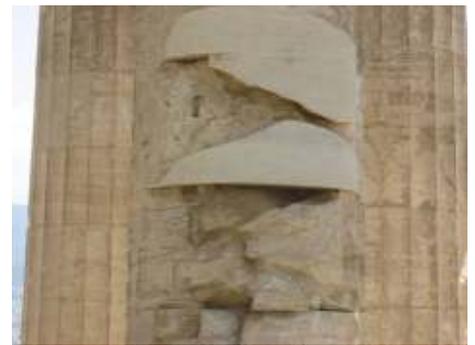
Figure 6: The fracture's limits follow the material layers

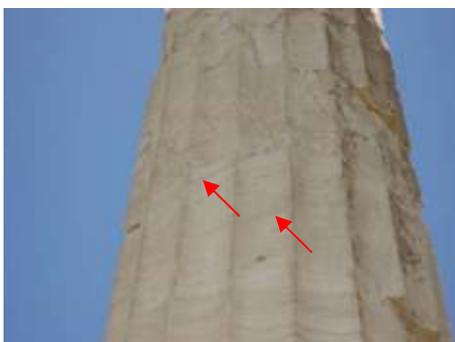
Figure 7: The upper drum of the depicted in Fig.6 has opposite geological stratification

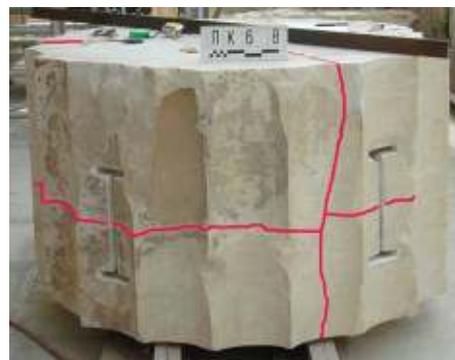
Figure 8: The fracture's limits follow the material layers

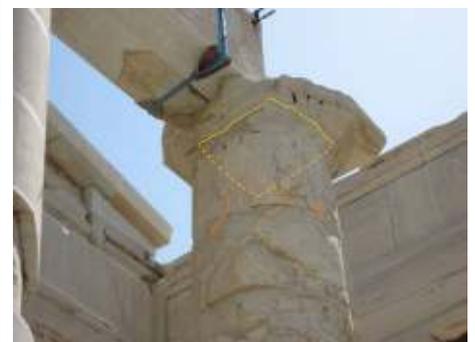
Figure 9: The resulting crack when a horizontal layer meets the main fracture's cross section

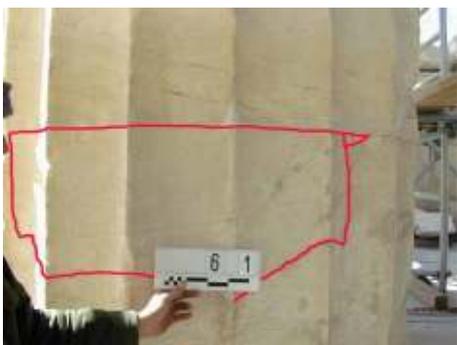
Figure 10: The continue of cracks within the layers

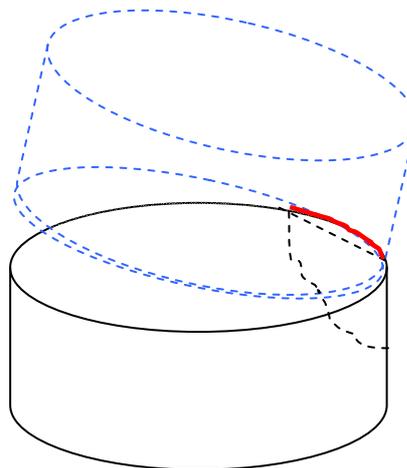
Figure 11: The right edge of the fragment coincides exactly with the conjunction of the layers on the upper side of the drum (see Fig.5)

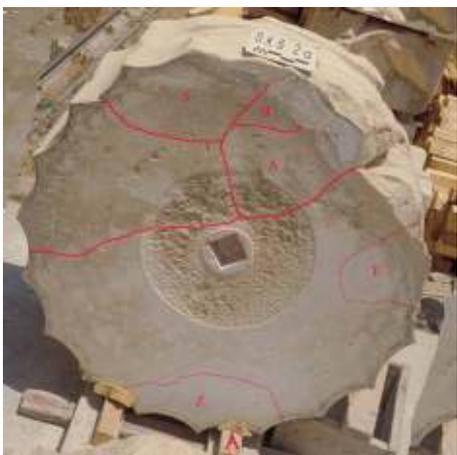
Figure 12: Genesis of the mechanism of fraction on the upper side (part) of the drum due to rocking (see Fig.11)

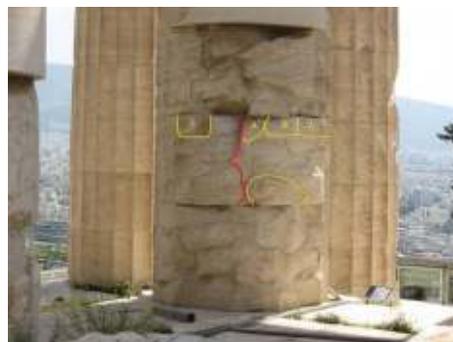
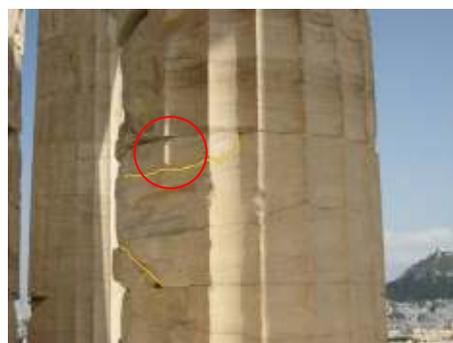
Figure 13: In the 2nd drum spots the penetrating break which separates the member in two pieces. The whole picture, together with the similar cut in the contact area to the next drum, implies a dynamic struck and gives its possible direction (see picture right above). It is easily to connect it with the explosion at 1687. In any case the fragments A, B, Γ and E are clearly due to the fire's effect, instead of Z and Δ which are antidiаметrical and might became from rocking in the axis east –west as it appear also from the crash of the edges (see picture right below)

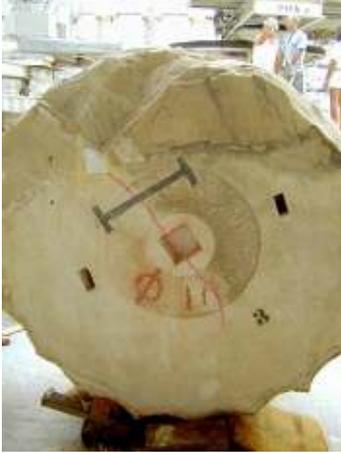
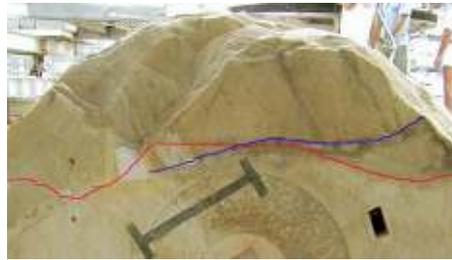
Dynamic actions provoked rocking, shifting or even twisting of the drums, which many times had lost their proper original seating. Although they have been already corrected by N.Balanos, the detailed observation succeeded to identify their movements as well as the direction of the phenomenon.

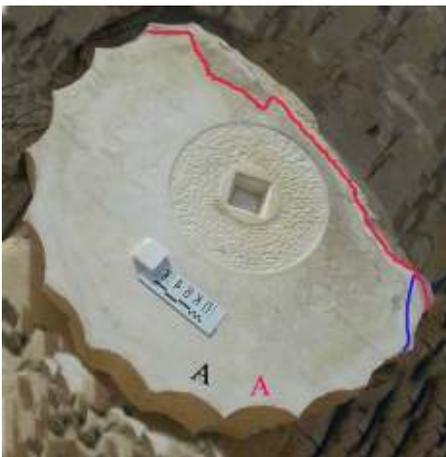
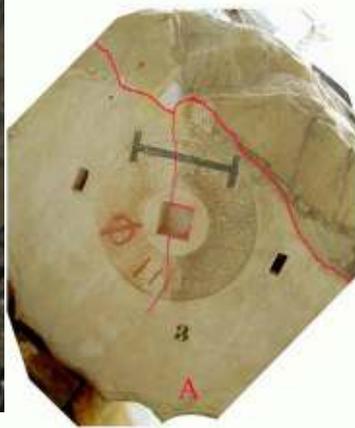
Figure 14: Two different positionings (due to movements after dynamic loadings) of the upper member of the drum left their traces upon its surface. The blue line indicates the reduced limits of the lower side on the next drum in its original place instead of the red line, which implies its rotation towards the south (see Fig.15)

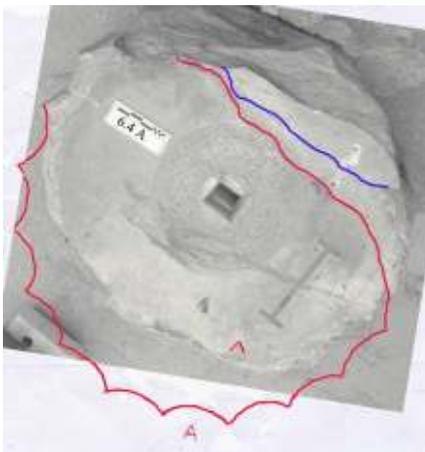
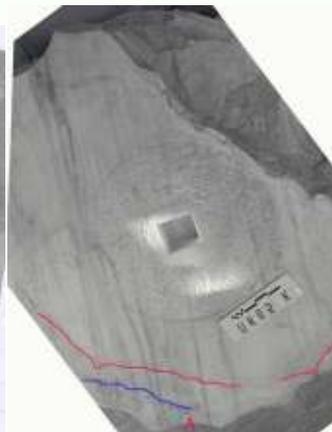
Figure 15: In left picture appears the reflection of the lower side of the next drum of the depicted one in Fig. 14, so in this way to reveal the coincidence of the outlines -right picture. With the letter A is symbolized the east for the drum in its original positioning and with **A** the real East. It is noteworthy that the beginning of the main crack of the drum in the right picture started from the point of the angular cut off on the surface which is also represents the boundary of the loading area from the upper member after the loss of

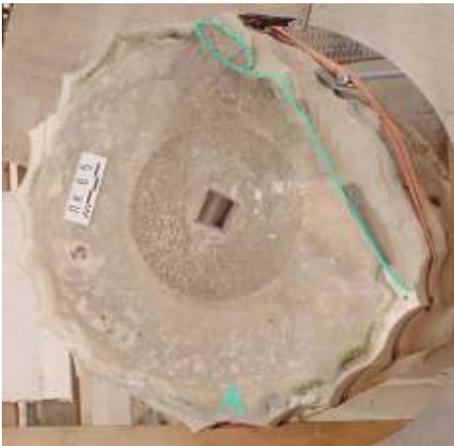
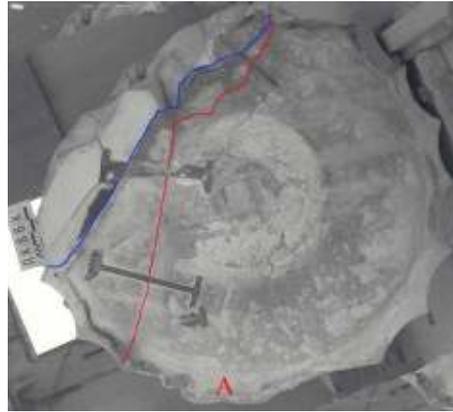
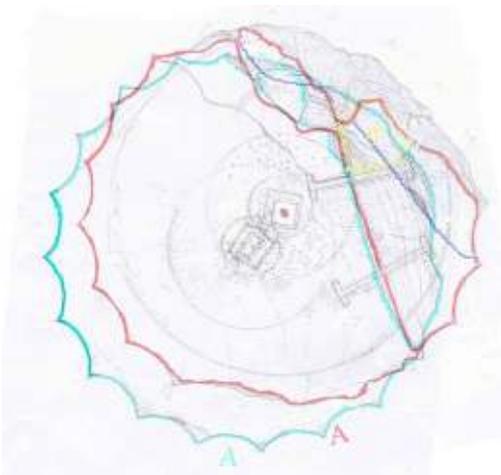
Figure 16: The cracks on the upper side of the 4th drum show the original and the relocated positioning of the 5th while they determine the limits of the missing part of the latter -left picture. The right picture is a reflection of the lower side of the 5th drum, where the marks of the 4th one are obvious.

The direction of the crack (left picture above) which is parallel to the missing front of the drum indicates also the direction of the rocking.

Yet to be noted the start of the main crack on the surface of the 4th drum which coincides with the

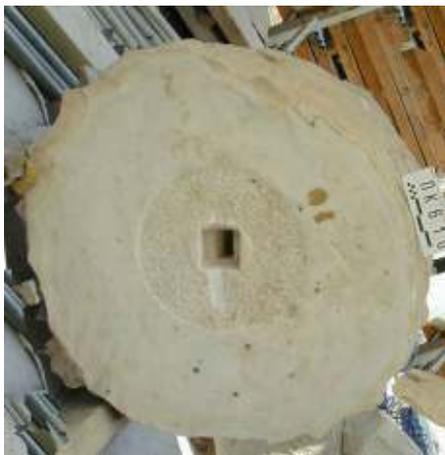
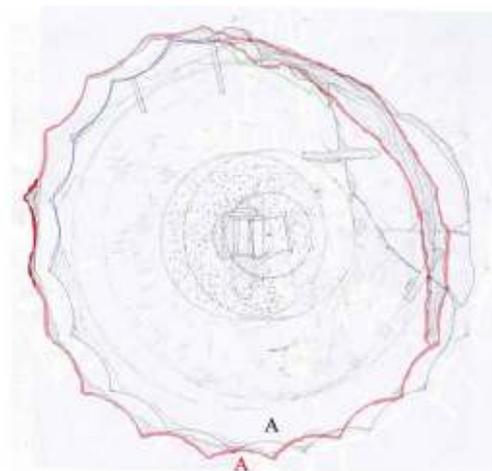
Figure 17: The comparison of the upper side of the 5th drum towards the lower side of the 6th one (pictures on the left and on the right above respectively) indicates the normal and the relocated positioning to each other. The former provoked to the latter the “blue” thin crack which represents the limits of its reduced surface, but also the red serious crack as the result of their conflict, when there were in a different relative connection than the original one (picture on the left). In the picture right above it also appears the crack due to iron’s expansion, beginning from the clamps’ head

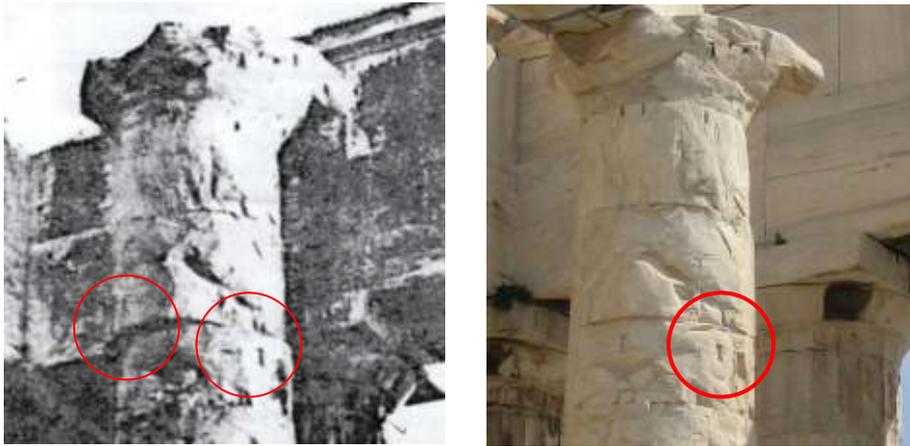
Figure 18: The traces on the upper side of the 10th drum represent clearly the movement of the 11th over the lower member (left picture). Their relative position is exactly depicted through the application of the sides’ plans which are in contact (right picture). This shift is also verified from Fig.19

Figure 19: The relation between 11th and 10th drum before any restoration and nowadays.
The left picture was taken by N.Balanos

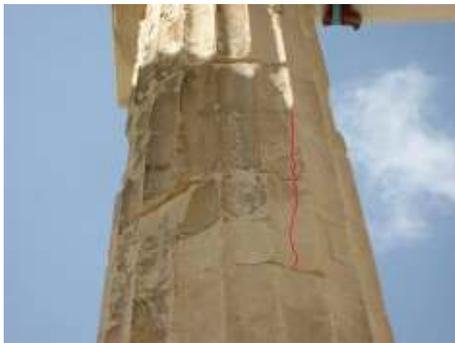
The observation of both the cracks or/and the fracture's plans of adjacent drums helps to understand the magnitude and the direction of the dynamic actions. For example the certain position of the continuous crack which appears in the east and south surface of the two adjacent drums (Fig 20, 21) implies to a rocking versus the axis N.W. to S.E. i.e. to the same direction which follows the penetrating fracture (came probably from the explosion) in the lower 7th drum (Fig.22).

Figure 20: East façade of the 6th column -cracks over the height in the 8th and 9th drum

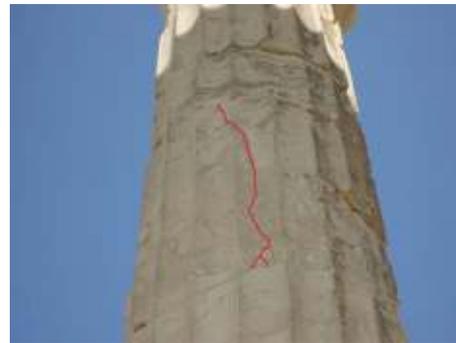
Figure 21: South façade of the 6th column -cracks over the height in the 8th and 9th drum

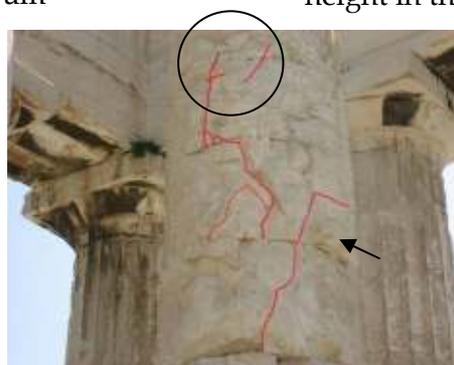
Figure 22: Northwest façade of the 6th column -the path of the cracks in the 7th, 8th and 9th

The aforementioned fracture is unified with the north limits of the fragment (type of wedge) near the lower side of the following 8th drum (Fig.22 pointed by the arrow), which lay in the west and was created as a result of rocking versus the axis E. to W. This same phenomenon provoked the continuous crack from the 8th to the 9th drum (Fig.22 also) although it is not easily directly recognizable, because the topical deviation near the base of 8th due to the combination of the thermal fraction and the geological stratification.
