DOCUMENTATION AND RESTORATION OF THE OTTOMAN MONUMENTS IN FLORINA

This paper concerns the historical and structural aspects, and the proposed restoration of the three remaining late-ottoman monuments in the town of Florina. These are the ottoman bath, part of a minaret and part of a defensive tower (kule). The presentation includes the historical data, the analysis of the typology and construction of the monuments, the building phases, the determination of their dating, the description of their pathology and, finally, the restoration proposal.

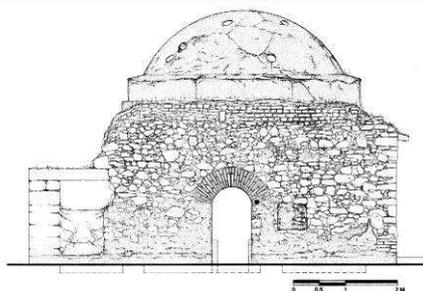
Figure 5: Ottoman bath. NE facade

The structural problems of the bath are mainly concentrated in its NE façade (partial demolition of the wall and the second entrance in the eastern corner) and in the eastern part of the additional spaces (possible collapse of the reinforced concrete roof and demolition of the wall). In the interior spaces, the renderings are severely damaged, and there is a serious erosion of parts of the walls. In the NE interior façade, this erosion is particularly evident in the upper part of the wall, whereas, at its base, parts of the original joint-fillings and rendering layers are preserved. In the NW interior façade, the most serious erosion is observed in the additional spaces, while in the central core a large part of the initial renderings is preserved. The SW façade is characterised by severe erosion of the renderings and the structural parts made of fired-clay bricks. Finally, the SE façade, which is protected by an improvised cover, is well-preserved.

- The rebuilding of the partially demolished eastern corner of the NE façade and the restoration of the second entrance to the bath with a similar morphology and construction to the central entrance, as well as the joint-filling of the stonework and the fixing of the remaining mortars at its lower part.

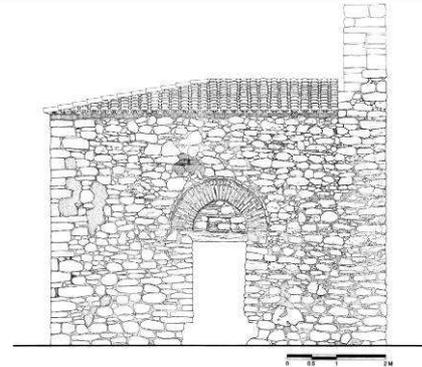
Figure 22: Kule. SE facade

The kule presents serious structural problems, which are due to the destruction of its western corner and part of the dome. In the main, SE façade, the damages include the erosion of the stonework over the arch of the entrance, where the internal, hidden, stone frame-work can be seen,

as well as at the base of the door. In this façade, as well as in the remaining part of the SW façade, the renderings have been almost fully destroyed. The NE façade is relatively well-preserved, especially concerning its lower part, where a large part of the initial joint-fillings can be seen, while its upper part presents erosion of the stonework (destruction of mortars and joint-fillings), as well as serious problems of dampness and vegetation. In the area of the external fire-place and above it, a large part of the initial layers of rendering (clay-mortars and lime-mortars) is preserved. In the interior space, there are detached renderings, especially of the final layer, whereas in the dome, many of the fired-clay bricks are eroded. The interior staircase bears damages in its stone stairs. Finally, most of the hidden timber ties in the interior of the walls have been destroyed.

- The fixing of the demolished part of the SE, main façade, the addition of fired-clay bricks in order to complete the semi-circular arch over the lintel and, finally, the joint-filling of the stonework.
- The rebuilding of the upper part of the NE façade in order to partially restore the original opening and window and make reference to the original form of the monument, which had two or three storeys. Apart from the above, fixing of eroded parts and joint-filling are also proposed, while it is possible that in-situ research may reveal the need of grouts in the interior of the wall.
- The fixing and joint-filling of the partially demolished SW façade and its rebuilding, together with the western corner and the NW façade, up to the existing roof in order to complete the
