# ULTRASONIC PULSE VELOCITY – A TOOL FOR THE CONDITION ASSESSMENT OF OUTDOOR MARBLE SCULPTURES

Marisa Pamplona<sup>\*a)</sup>, Abdelraheem Ahmad<sup>a)</sup>, Stefan Simon<sup>a)</sup>, Edda Aßel<sup>a)</sup> and Andreia Theissen<sup>b)</sup>

<sup>a)</sup> Rathgen Research Laboratory, National Museums Berlin

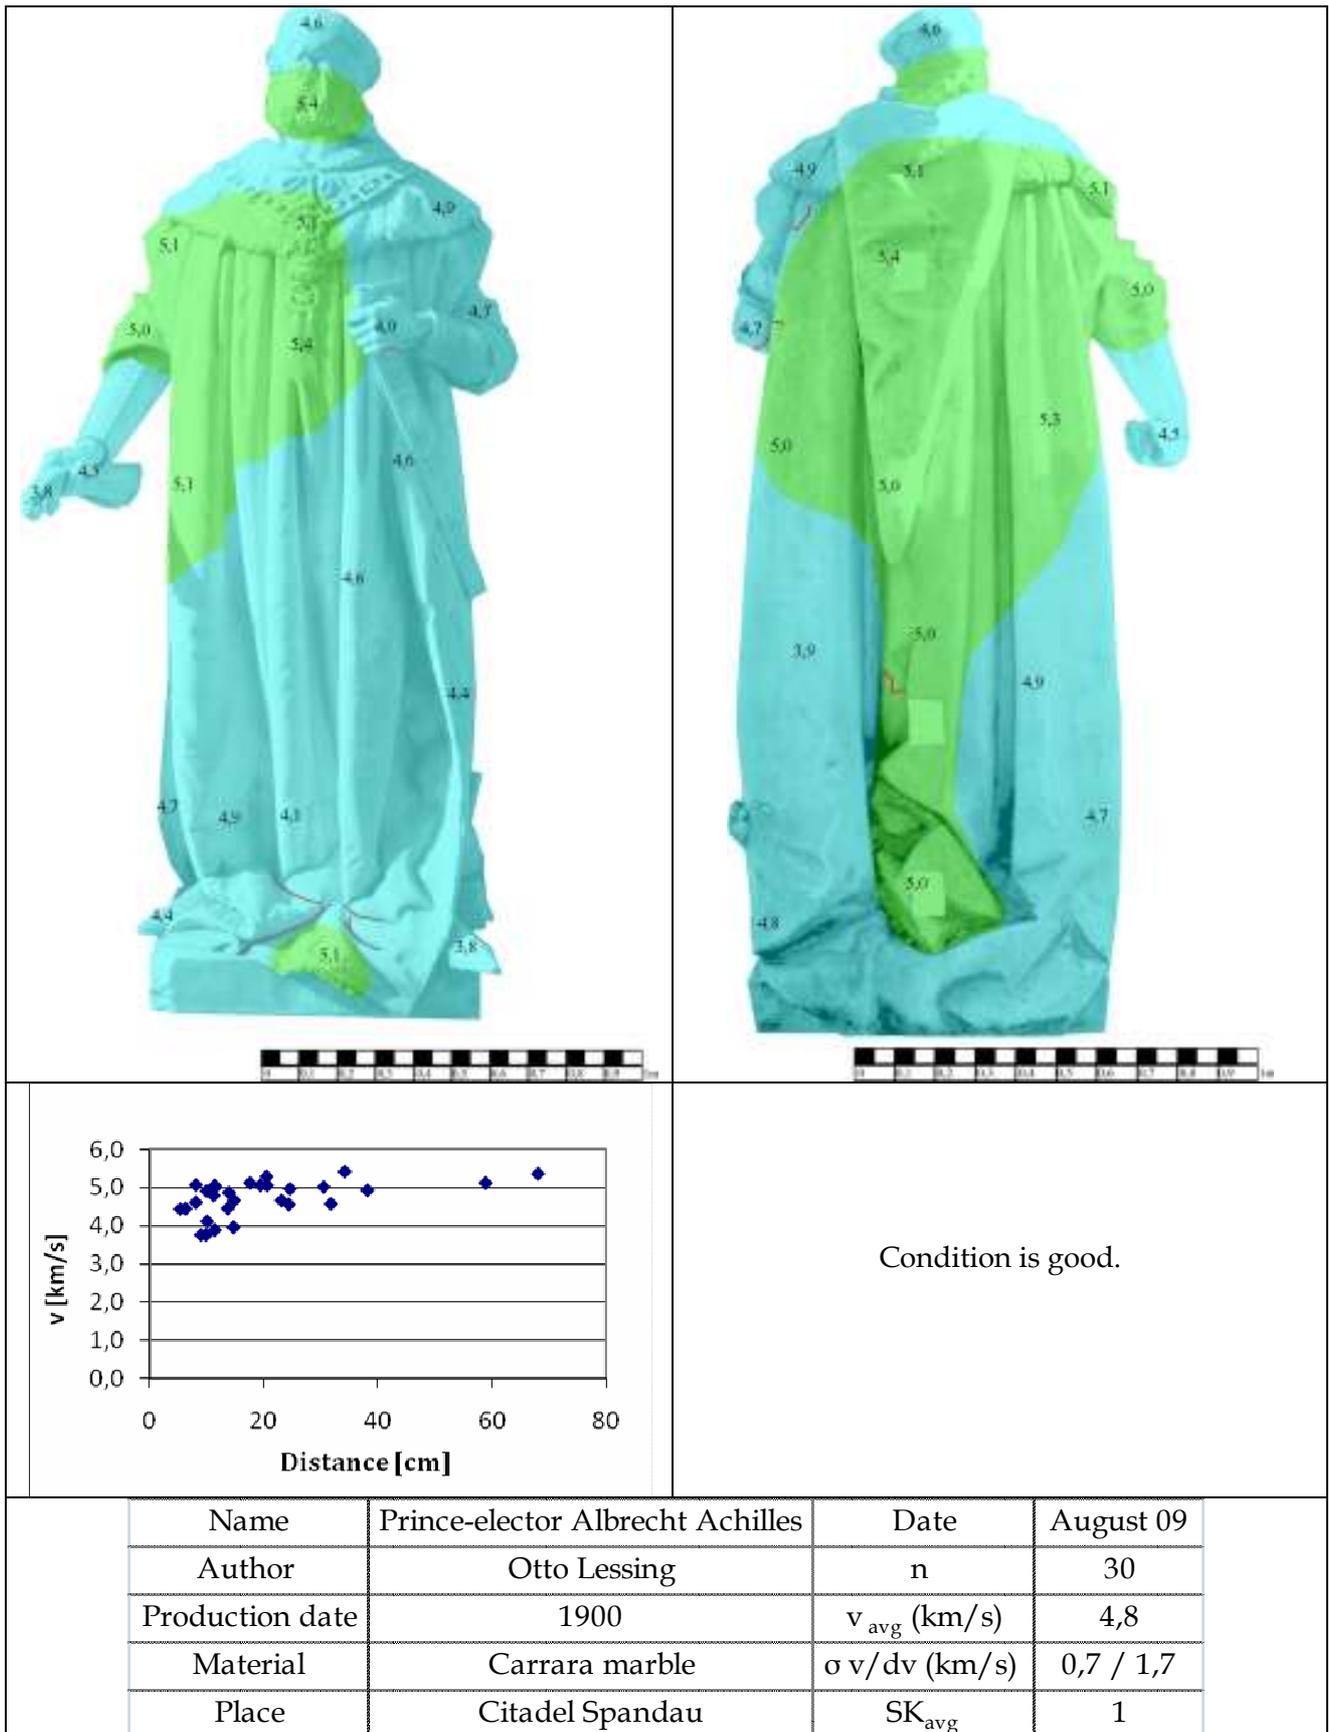
- 3 figures have surfaces which fall into the class 0 and class 1 (see e.g. Fig. 1)
- 10 figures have surfaces which fall into the class 0, class 1 and class 2 (see e.g. Fig. 2)
- 8 figures have surfaces which fall into the class 1, class 2 and class 3
- 5 figures have surfaces which fall into the class 2, class 3 and class 4 (see e.g. Fig. 3)

**Figure 1:** Prince-elector Albrecht Achilles has average damage class 1. Some areas have damage classes 0 and 1.

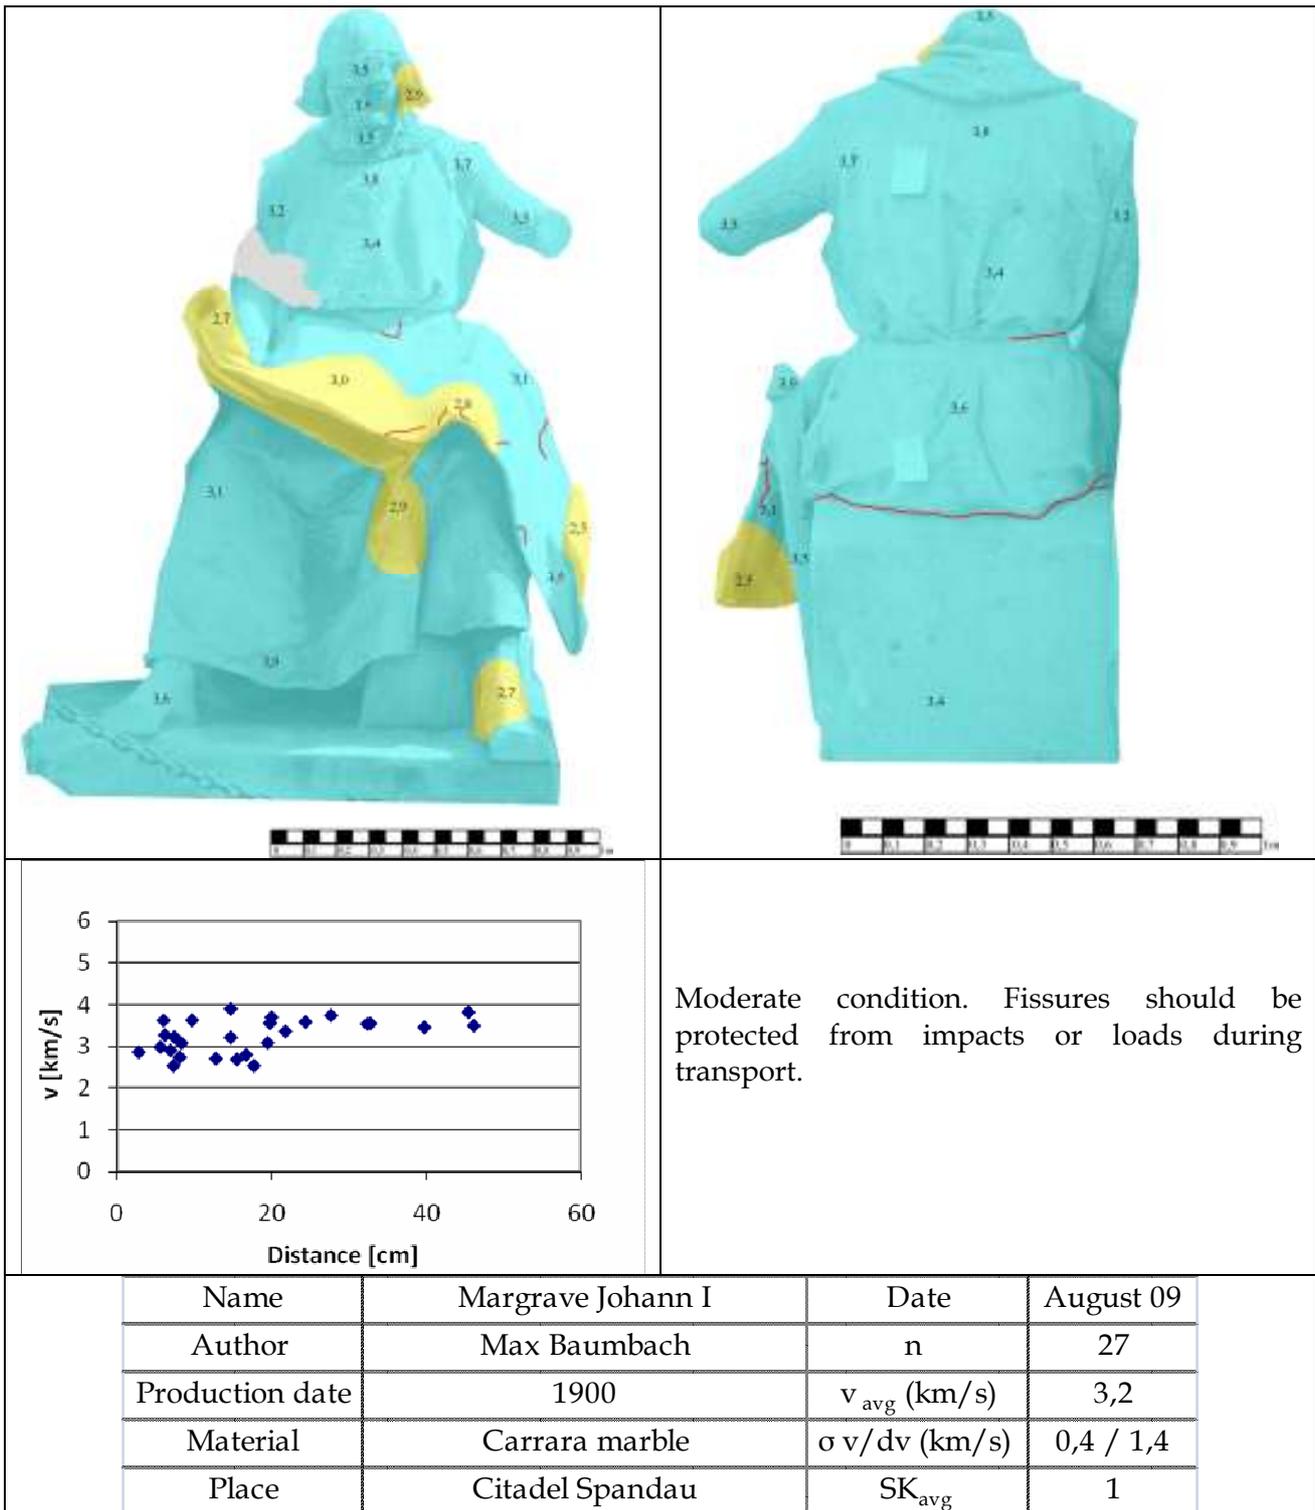
Figure 2: Margrave Johann I has average damage class 1. Some areas have damage classes 1 and 2.

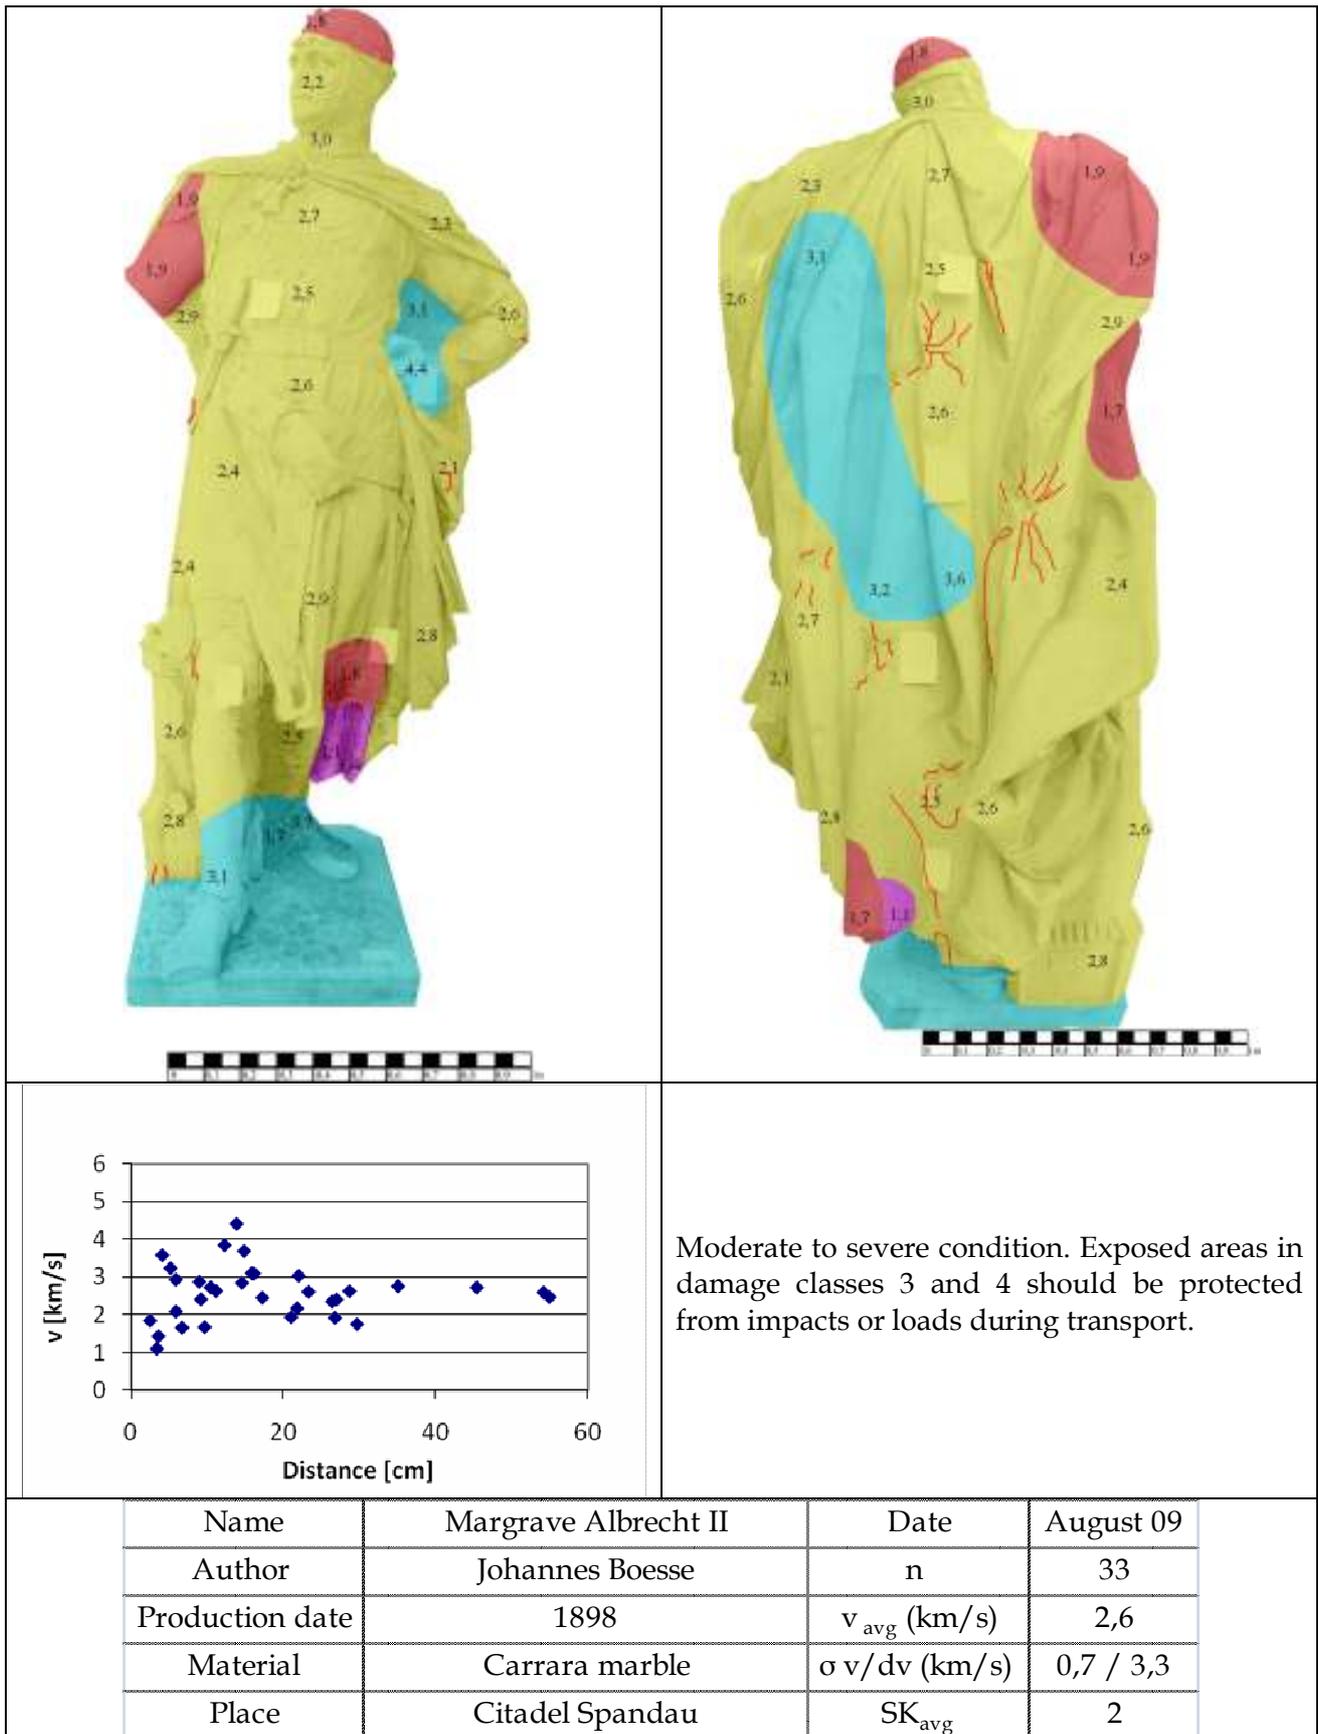
Figure 3: Margrave Albrecht II has average damage class 2. Some areas have damage classes 1, 2, 3 and 4.

The 13 figures that have surfaces which fall into the class 3 and class 4 should be very carefully transported to the new exhibition room of the Citadel Spandau. The mapping allows to locate clearly which areas are more fragile and need to be protected during transport. Several cracks should be observed during and after transport, in order to assure that they do not grow.

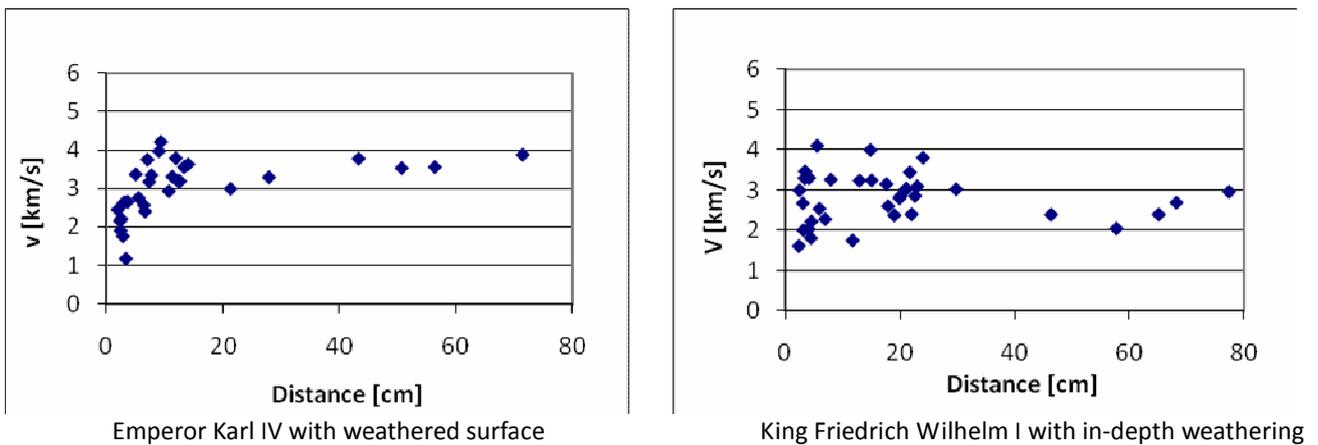
The velocity-distance graphs allow to address the question whether the weathering progress is homogeneous or not [15] and recognize the inner weathering, which is common for crystalline marbles. From the 26 investigated figures, 23 have the outer surface more weathered than the inner core. There are 3 figures however, which seem to have inner-core weathering (Figure 4). For these 3 figures a consolidation treatment might be considered.

**Figure 4:** Distance-velocity graphs of sculptures showing marble weathering at surface level (left) and marble with in-depth weathering (right).

Further measures as stabilization of cracks, localized or full consolidation treatment are to be discussed and if appropriate, they shall be carried out after testing of products and assessment of their effectiveness with ultrasonic testing. If the 3 sculptures with in-depth weathering are to be consolidated, ultrasonic tomography should be used for the assessment of product effectiveness.

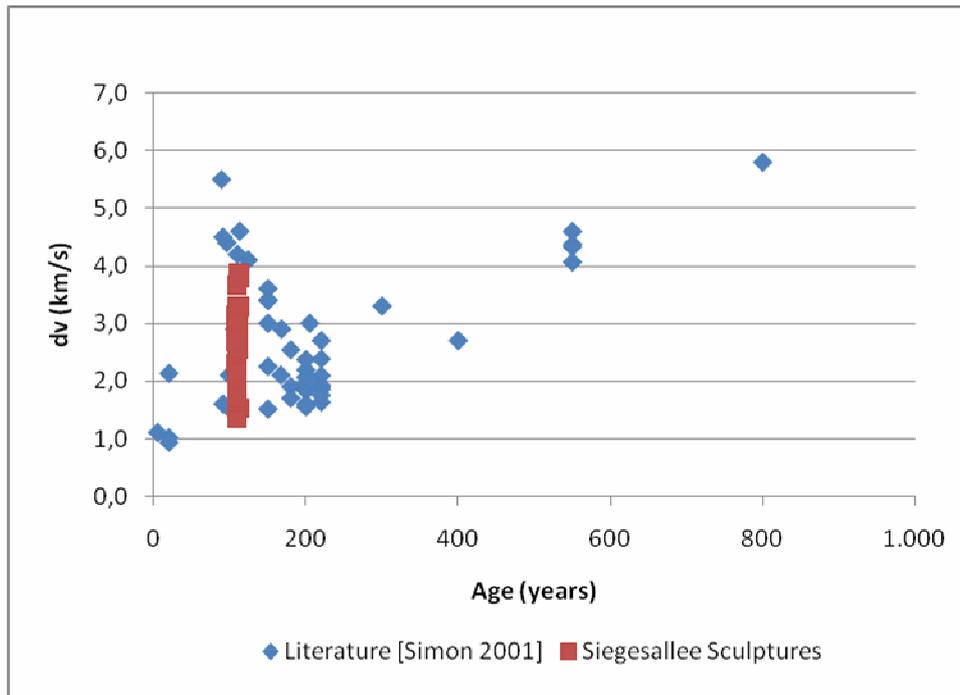
For marble sculptures it was noticed by Simon [16] that the range of deviation in UPV increases with age. Noticeable is a significant scattering for sculptures which were produced around the 1900s. At this period, an increasing interest in statuary marble in Europe went with a quality decrease of the delivered marble [16]. The Siegesallee sculptures are ca. 110 years old and the scattering of their range of deviation (maximum-minimum values) in UPV agrees well with the tendency previously noticed by [16] (Figure 5).

**Figure 5:** Range of deviation (dv [km/s]) of ultrasonic data collected from Siegesallee sculptures and data from [16] in relation to the sculptures' age.
