## PARTLY DESTROYED STONE BRIDGES WITH LONG-TERM USE

**Keywords:** *Stone bridges, Intervention, Multi-arched, Partial Rebuilt.*

### ABSTRACT

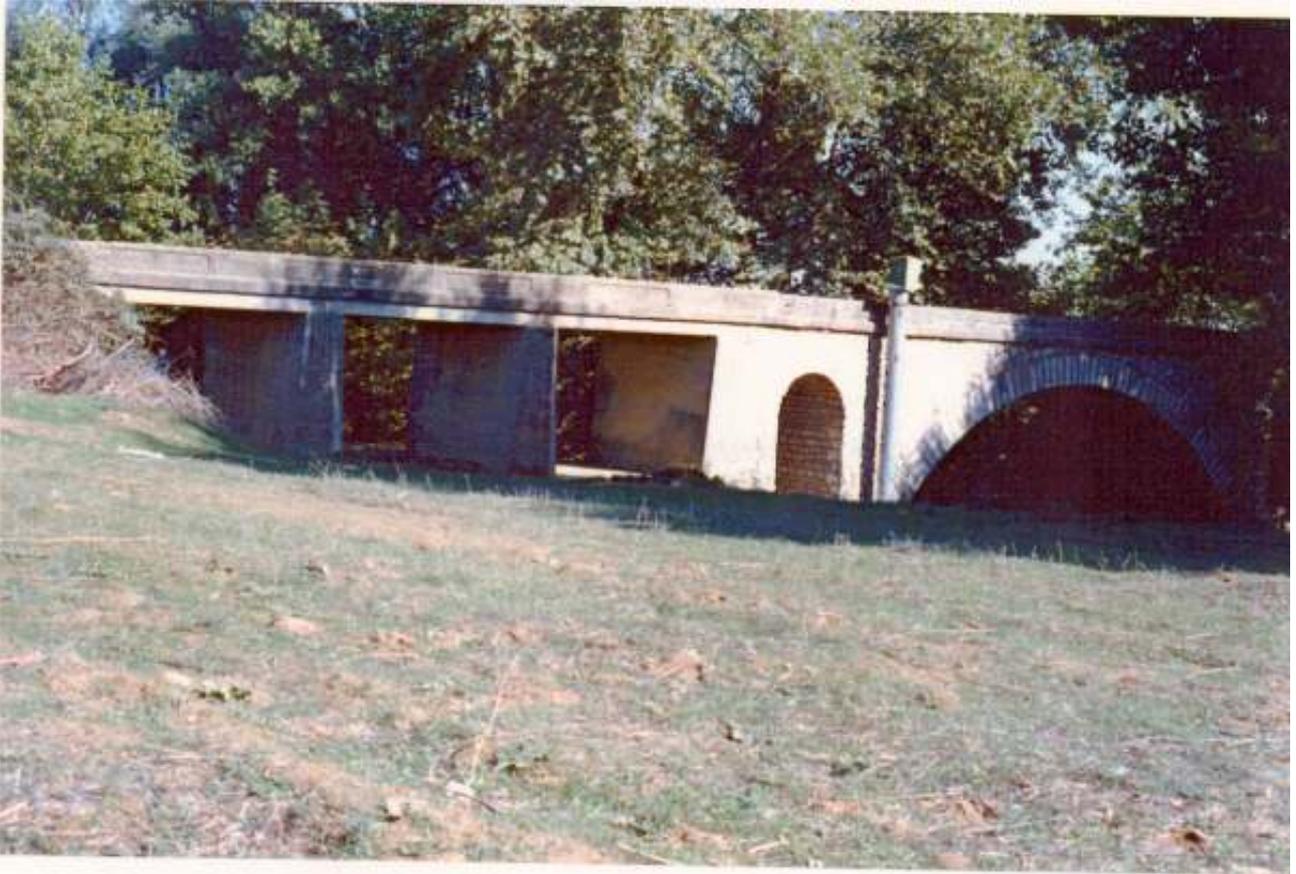
**Figure 1** Karditsa Bridge at the beginning of the 21th century

Karditsa stone bridge was built at the last decades of the 19<sup>th</sup> century. It is located at a distance of 5 km from the town of Karditsa over Kalentzis river. The original structure had three main arches but only the middle of them survived till now. The collapsed arches had been replaced by a reinforced concrete structure in order to ensure further use of the bridge (Fig.1). This intervention at the beginning of the second half of the 20<sup>th</sup> century had been made without any respect to the original stone system presented by one semi-circular arch and two relieving openings on the right and the left of it (over the stone piers). For more than five decades (until the half of the first decade of the 21<sup>st</sup> century) the composite bridge was used for heavy traffic loads in the Karditsa region in Central Greece.

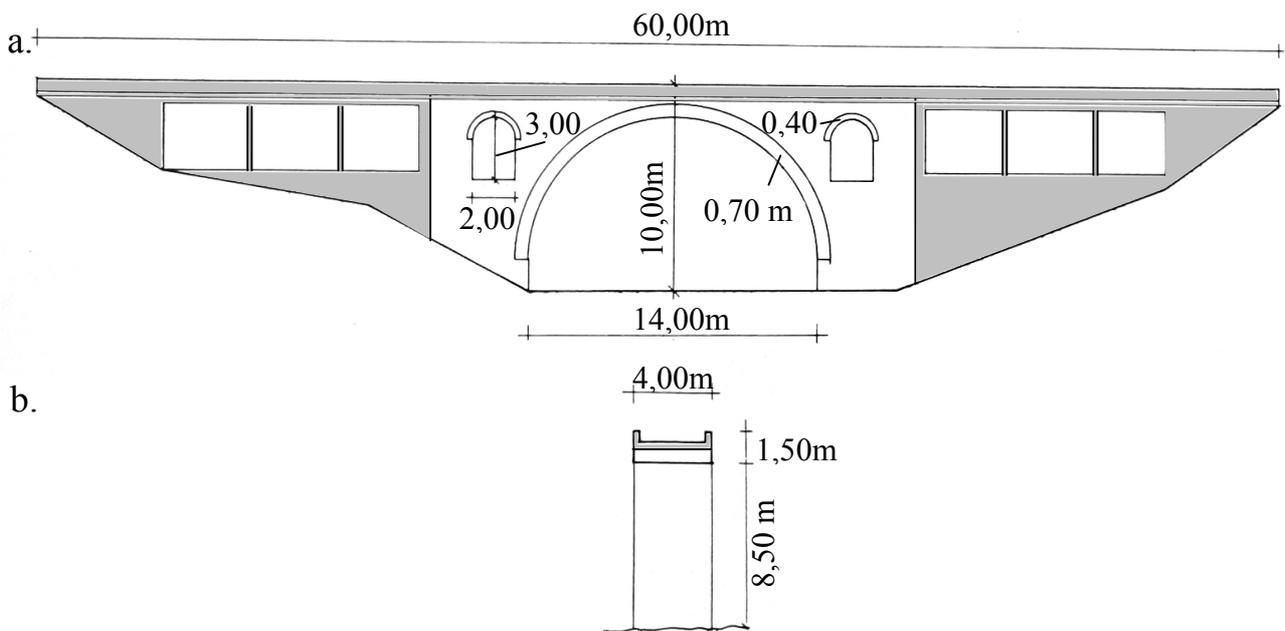
The total length of the original stone bridge is unknown but the one of the structure after its repair with reinforced concrete was 60m approximately (Fig. 2). The width of the stone bearing system is 4.00m. The parapet has a width of 0.30m and a height of 0.50m.

**Figure 2** Geometrical data of Karditsa Bridge (a. longitudinal section, b. section at the key)

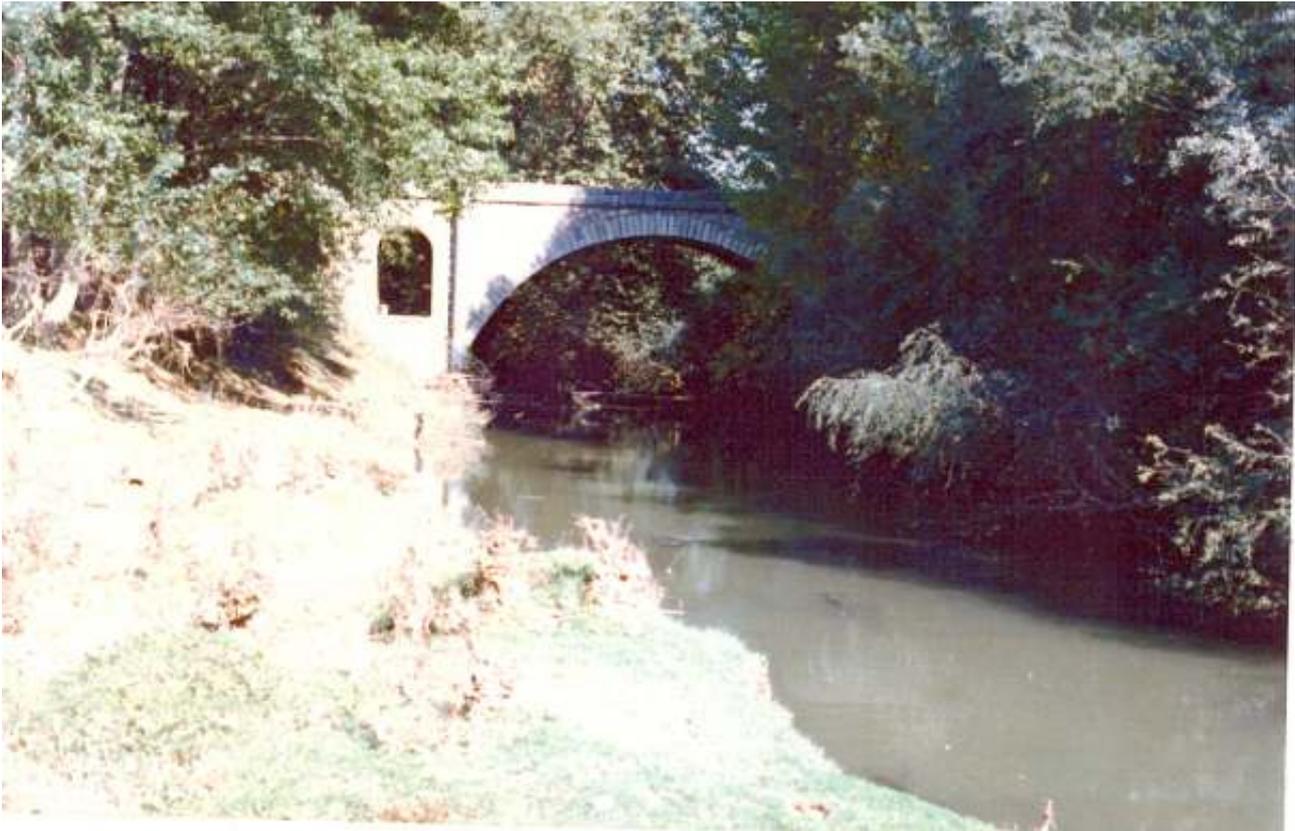
In the stone part of the bridge the cornices are made of curved lime stone, the spandrel masonry of hewn lime stone. From time to time the stone masonry joints were repaired with cement mortar. The signs of weathering and ageing were obvious on both parts (masonry and reinforced concrete) of the bridge.

**Figure 3** The stone part of Karditsa bridge

Interventions for the strengthening of the existing old structure and its promotion in the region on the part of the authorities for the preservation of the old stone bridge must be taken into account under consideration of its historical value. A rebuilding of the missing part of the stone bridge cannot be useful because a modern bridge for heavy traffic will be built near the old one. The location of the bridge as well as its surrounding is suitable for a recreation park with the existing stone part as focal point. However an additional structure (stairs) could help visitors to reach the

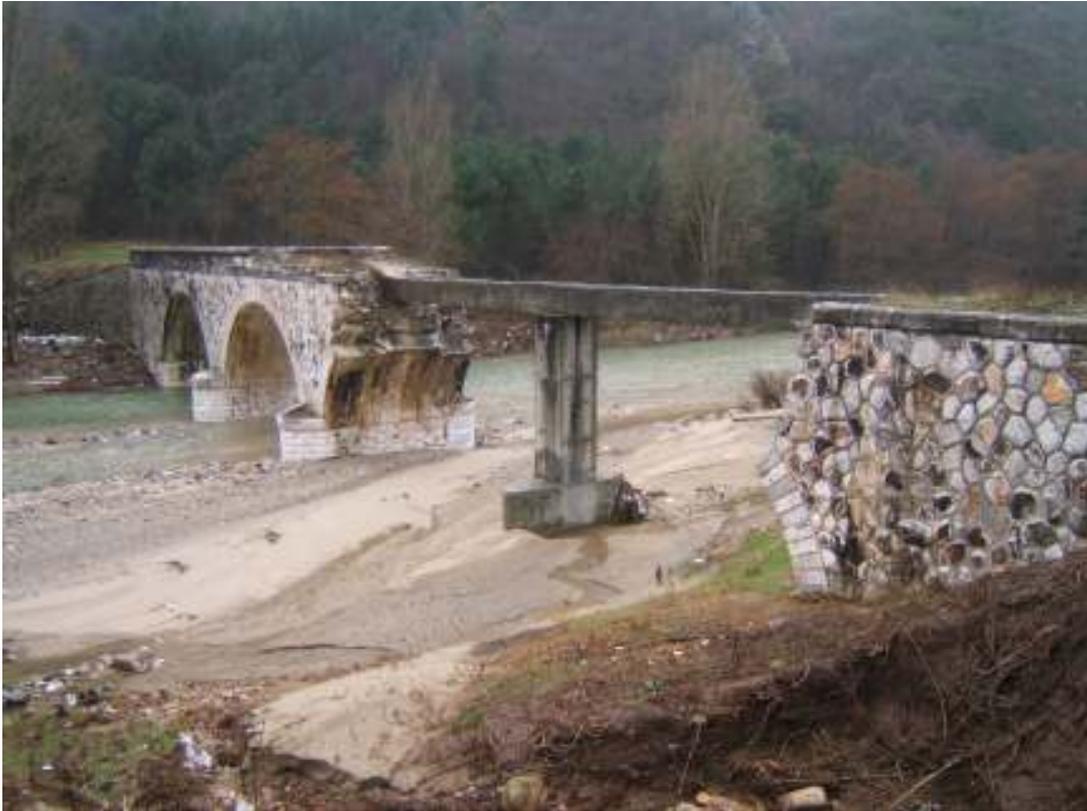
The second stone bridge presented in this paper is an old structure which was blown up in the World War II (perhaps 1940) and it lost two of the four original arches. At a distance of 3km from the old structure a new bridge was built in order to serve the local traffic. The old bridge was abandoned. A new need enabled the old manufacture to preserve a functional character in a different context. Since some decades the bridge supports the water main of the water supply of the town Xanthi (Eastern Greece). For this function two beams and one pier constructed with reinforced concrete replaced the missing part of the original bearing structure (fig. 4, fig 5).

The original part of the structure is made of curved white lime stone and its total length was 66m approximately [4]. The great width of the superstructure, over 4m, testifies the importance of this road during the last century. Nowadays the existing two of the original four arches and the abutments demonstrate that the involved builders created an excellent feature. As mentioned above, a slender reinforced concrete structure replaced the lost arches and the pier between them in order to serve the water transportation. Unfortunately the primitive concrete structure causes a distortion to the elegant figure of the old damaged bridge. The local authorities built the reinforced concrete part according to the real needs of the communities and ignored the message handed down by the old stone masonry, because of the high cost of rebuilding the missing part with stone. The abandoning

of the mountainous region in the second half of the last century, the weathering and ageing contribute, in the run of time, to the damage of the stone part of the bridge as since a lot of years works for its preservation are not carried out.

**Figure 4** The Abdoul Hamid bridge nowadays (2010)

- repair and rebuilt with stone masonry of the damaged part of the Abdoul-Hamit bridge and the existing one of the Byzantine construction
- aesthetic improvement of the surrounding of them and perhaps providing for tourist service in the site.

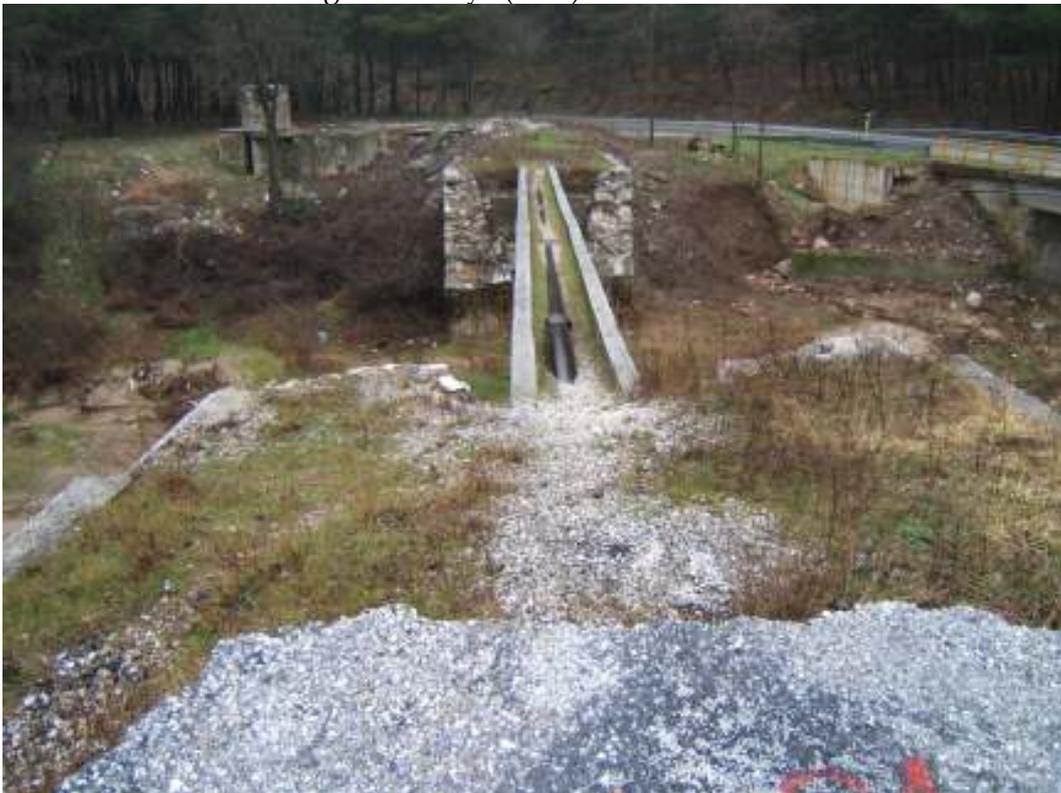
**Figure 5** The water main in the reinforced concrete part of Abdoul Hamid bridge (2010)

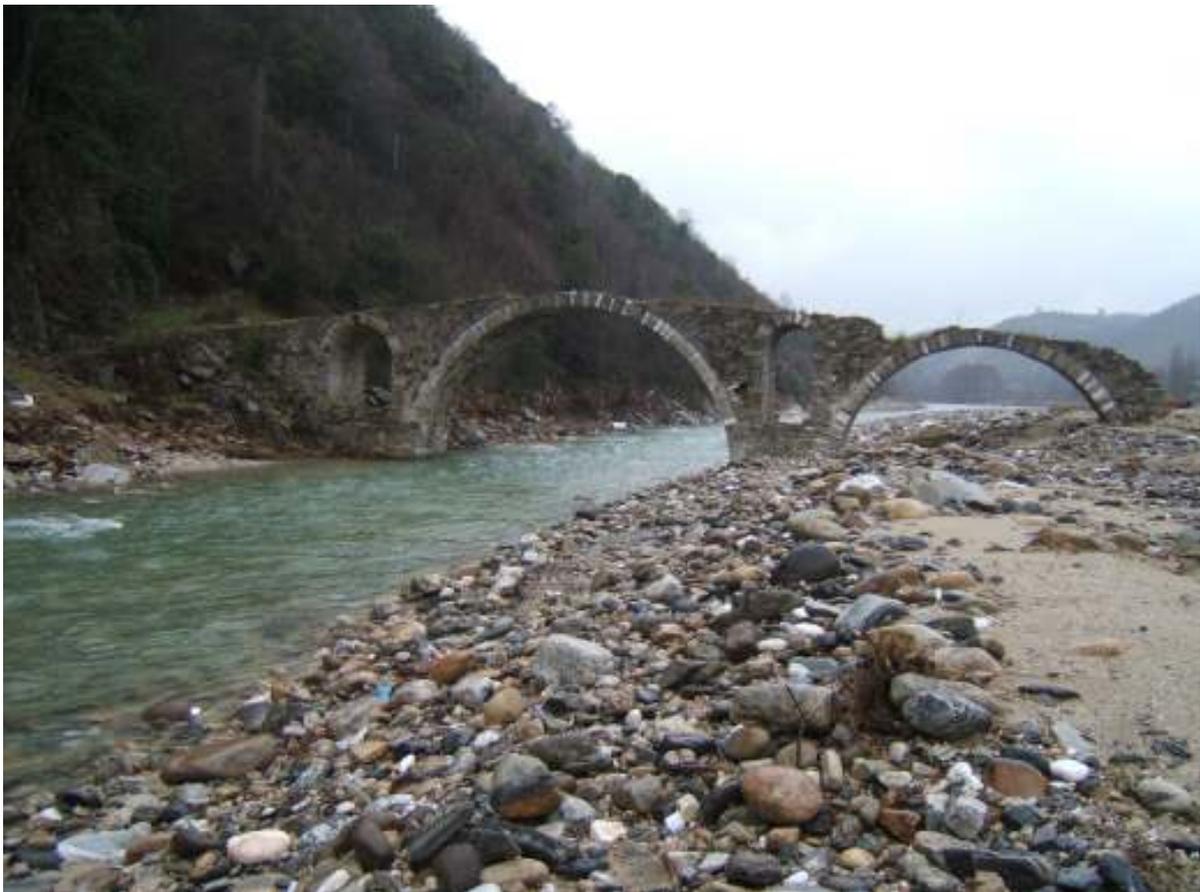
It is remarkable that at a distance of 1km from the Abdoul Hamid bridge there exist two stone arches (and two relieving openings) of a Byzantine multi-arched stone bridge (Fig.6), built in the 16<sup>th</sup> century. Obviously the tortuous mountain road Xanthi-Stavroupoli-Drama was the main artery of communication in this part of Thrace since several hundred years.

**Figure 6** Remains of a Byzantine bridge close to Abdoul Hamid bridge nowadays (2010)
