DOCUMENTATION AND RESTORATION OF THE OTTOMAN MONUMENTS IN FLORINA

This paper concerns the historical and structural aspects, and the proposed restoration of the three remaining late-ottoman monuments in the town of Florina. These are the ottoman bath, part of a minaret and part of a defensive tower (kule). The presentation includes the historical data, the analysis of the typology and construction of the monuments, the building phases, the determination of their dating, the description of their pathology and, finally, the restoration proposal.

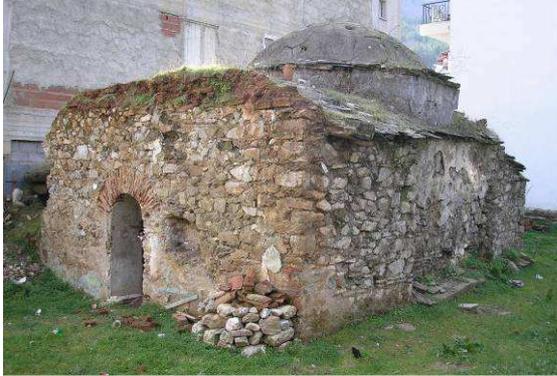
Figure 1: Ottoman bath. N view

The structural problems of the bath are mainly concentrated in its NE façade (partial demolition of the wall and the second entrance in the eastern corner) and in the eastern part of the additional spaces (possible collapse of the reinforced concrete roof and demolition of the wall). In the interior spaces, the renderings are severely damaged, and there is a serious erosion of parts of the walls. In the NE interior façade, this erosion is particularly evident in the upper part of the wall, whereas, at its base, parts of the original joint-fillings and rendering layers are preserved. In the NW interior façade, the most serious erosion is observed in the additional spaces, while in the central core a large part of the initial renderings is preserved. The SW façade is characterised by severe erosion of the renderings and the structural parts made of fired-clay bricks. Finally, the SE façade, which is protected by an improvised cover, is well-preserved.

The exterior side of the dome has sustained severe damages (replacement and covering of slate with cement rendering) and has problems of cracks, dampness and vegetation. In the interior, there is detached rendering on many parts of the walls, especially in the hot space. In the lower zone of the SE and SW side, as well as in an intermediate zone of the NW and the NE side, the problems of erosion are particularly evident, while in many parts the fired-clay bricks are also severely eroded. The dome presents problems of dampness and vertical cracks on its western side. Finally, part of the marble floor has been destroyed, as a result of a contemporary violation, revealing the construction of the hypocaust. The individual bath and the antechamber present far less damages, which mainly involve detached renderings.

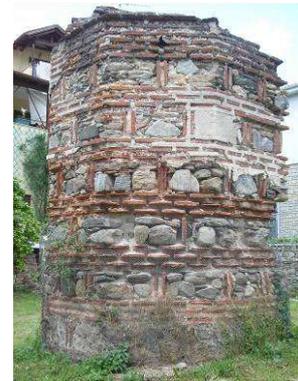
Figure 13: Minaret. S view

The minaret, despite the destruction of its upper part, does not present problems related with the structural ability. Nevertheless, the renders and the walls (mortars and fired-clay bricks) of the SW part (S and W façade) are severely eroded due to their exposure to weather conditions. The walls of the facades are damaged, apart from the base, where there is vegetation, apart from NW part, which is preserved in a very good state, presenting only mildly damaged renderings, especially in the parts where the minaret was adjacent to the mosque. Apart from the above, the fact that the upper part is destroyed and uncovered causes problems of dampness, vegetation and severe erosion, due to the extreme weather conditions that prevail in Florina throughout the most part of

For the minaret, fixing works, such as replacement of eroded parts, reconstruction of the destroyed parts of the brick-enclosed system (fired-clay bricks and mortars), are proposed. The reconstruction can be carried out with bricks that may be found during the full-scale archaeological research, or with new bricks of similar composition and dimensions (25.5 x 25.5 x 4 cm). The initial form of the rendering of the brick-enclosed system is proposed for all five facades, after the analysis of the chemical composition of the existing, initial renderings. For the eastern façade, which was adjacent to the mosque, the fixing of the stonework with joint-filling is suggested. Finally, the partial reconstruction of the base of the upper part of the minaret with the use of fired-clay bricks of appropriate dimensions, as well as the completion of the destroyed staircase steps, are proposed.

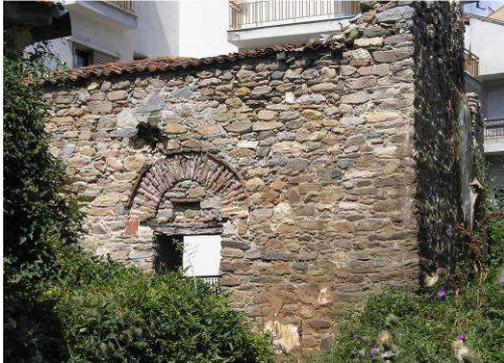
Figure 19: Kule. SE view

The kule presents serious structural problems, which are due to the destruction of its western corner and part of the dome. In the main, SE façade, the damages include the erosion of the stonework over the arch of the entrance, where the internal, hidden, stone frame-work can be seen,
