PETROGRAPHIC CHARACTERIZATION OF RENDERS FROM THE LUCCHESIAN VILLAS

Laura Bolondi
TU Delft, Faculty of Architecture
Julianalaan 134, 2628 BL Delft, The Netherlands

Timo G. Nijland, Rob P.J. van Hees
TNO Built Environment and Geosciences
P.O. Box 49, 2600 AA Delft, The Netherlands

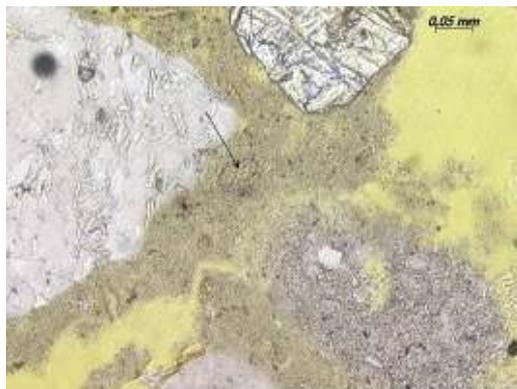
Figure 6: Sample VB-PV-R-06, minute pozzolanic components in Layer 1 (all pictures plain polarized light).

Five samples from Villa Burlamacchi were analyzed by PFM: they differ in structure depending from the building they have been collected from. This is probably due to different restorations periods of the buildings in the villa. However, aggregates in the different renders are similar, mainly constituted by quartz, sandstone and minor amounts of limestone and metamorphic rock, as is the type of binder: lime, with minute, not indentified pozzolanic (or hydraulic) additives. Samples from the palace of villa are composed by up to four layers, most show a mortar with two lime washes on top. One sample (VB-PV-R-06) from the palace of villa contains a second external render layer characterized by the presence of a green pigment. Samples from the parish show a complex stratigraphy of eight different layers, with three renders separated by finishing layers.

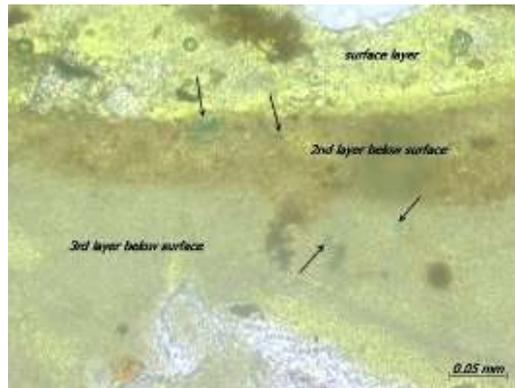
Figure 7: Sample VB-PV-R-06, green pigment in Layers 2 and 3

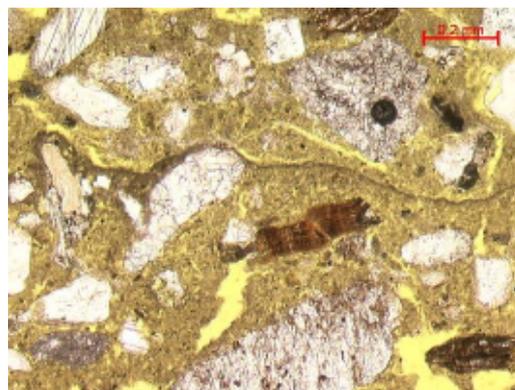
Figure 8: Sample VR-VOW-R-02, boundary between Render 1 and 2

Six samples from Villa Reale have been analyzed with PFM: one from the Orthodox chapel, two from Villa del Vescovo and three from Villa dell’Orologio (from different sides of the building). Samples VR-VV-R-05, VR-VV-R-07, from Villa del Vescovo, and VR-VOW-R-02 from the west side of Villa dell’Orologio are composed by three layers: a couple of renders and a finishing (lime wash or colour) layer, recomposed in this way. In Sample VR-C-R-01, from San Biagio’s chapel, a single render and a double finishing layer (lime wash and colour) occur. Sample VR-VO-R-02 from the central building of Villa dell’Orologio is composed by six different layers: three renders and three finishing layers (two colours and a lime wash). Sample VR-VOE-R-01 from the eastern wall of Villa dell’Orologio differs from other samples in composition and structure: it is constituted by a cement-based render and a colour layer. Aggregate composition is similar in all the samples: quartz, sandstone and limestone are most abundant; schist is also present. The microstructure of the lime-based binder differs in internal grain size and porosity. In the matrix, wood occurs: in Italian building tradition, wood chips were sometimes added to mortars to avoid or limit shrinkage. On the basis of PFM observation, a stratigraphic chronology of the analyzed renders was deduced.

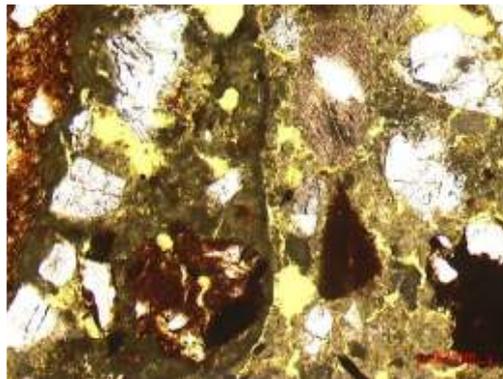
Figure 10: Sample VM-POE-R-03, boundary between Render 2 and 3

Four samples from the Palazzina dell'Orologio in Villa Mansi have been analyzed. Two of them were sampled on the eastern side (samples VM-POE-...), one from the western (VM-POW-...) and one from the southern part (VM-POS-...). They represent all the areas of the Palazzina, built at the end of 17th century and modified several times. The last renovation involved the southern part of the building; it was modified into a small castle - following the Neo-gothic style - in 19th century. Collected renders are composed by many layers. The most complex sample is VM-POE-R-03, in which four mortar layers occur: two pure lime and two cocciopesto renders. In the latter, fine ground brick fragments have been added as pozzolana. Sample VM-POW-R-01 is also composed by four layers: two renders, one lime-based and one cocciopesto, and two finishing layers (a lime wash and a colour). In sample VM-POS-R-01, only a render and colour layer are present; in sample VM-POE-R-02, a single render occurs.

Except for VM-POE-R-02 - containing a render not present in any other analyzed sample - and for renders 1 and 4 in VM-POE-R-03, all the renders and have been found in more than one sample, permitting a chronological reconstruction of building periods. Colour layers were also important in order to correlate samples. VM-POS-R-01 and VM-POW-R-01 have the same colour layer, indicating that the underlying layers probably represent the same mortar.

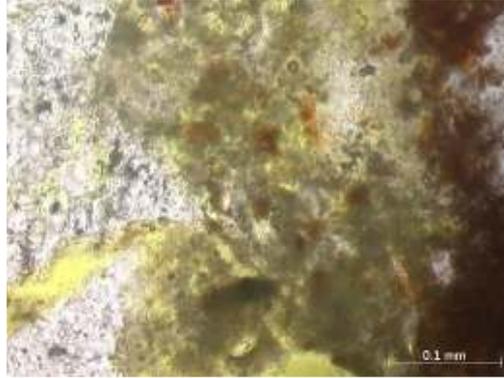
Figure 11: Sample VM-POE-R-03, binder of the external cocciopesto layer

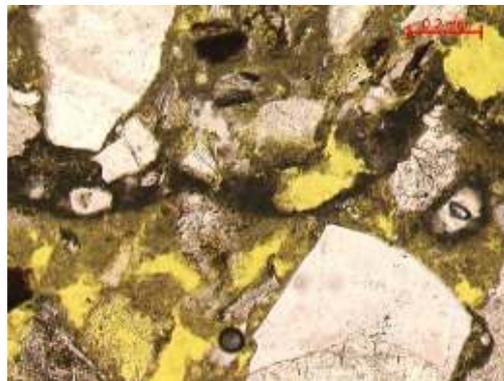
Figure 12: Sample VT-F-R-07, boundary between renders

Four samples from Villa Torrigiani have been analyzed: one from the coffeehouse, two from the farm and one from the western area of Borgo a Parigi. They show a comparable structure: one or two layers of mortar and a finishing layer, either limewash or coloured layer. Renders are very thin and fine grained. Four different kinds of mortar have been detected: sample VT-F-R-07 from the farm, containing two renders, and VT-BPW-R-05 from the western part of Borgo a Parigi are composed by the same mortar. Samples VT-F-R-06 from the farm and VT-CH-R-01 from the coffeehouse are both composed by single mortars different from each other and from the one in VT-F-R-07 and VT-BPW-R-05. Renders of Villa Torrigiani are lime-based with pozzolanic or hydraulic additives; aggregates are mainly composed by quartz, sandstone, limestone and metamorphic rocks. In addition, fragments of straw are present. Similarly to the wood fragments of Villa Reale, they have probably been added to limit shrinkage.
